# DDESS Facility Transfer Study Facility Condition Report (Final)

## Fort Rucker, Alabama

December 10, 2003

**FORT RUCKER SCHOOLS  
FORT RUCKER, ALABAMA  
PROPERTY CONDITION REPORT**

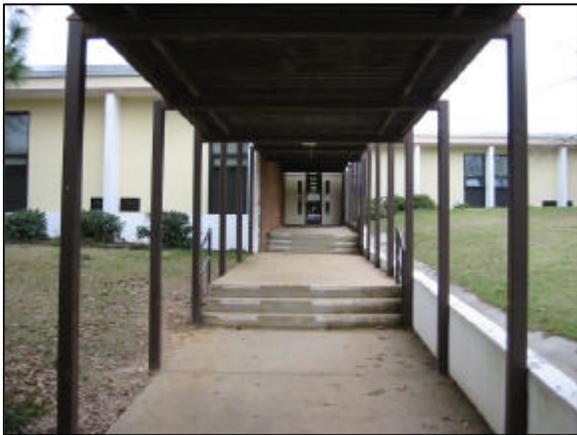
**ADA Non-compliant Exit/Entrance**

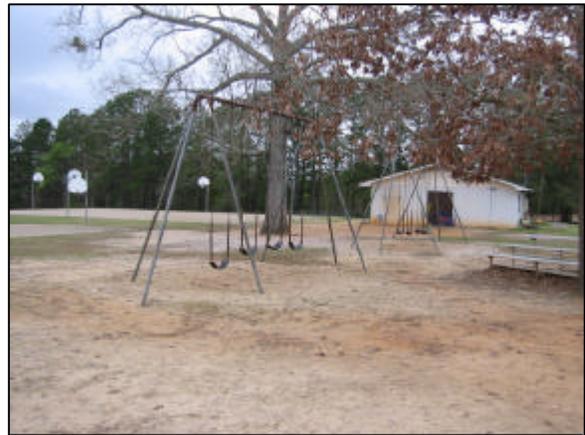
**ADA Non-compliant Play Area**

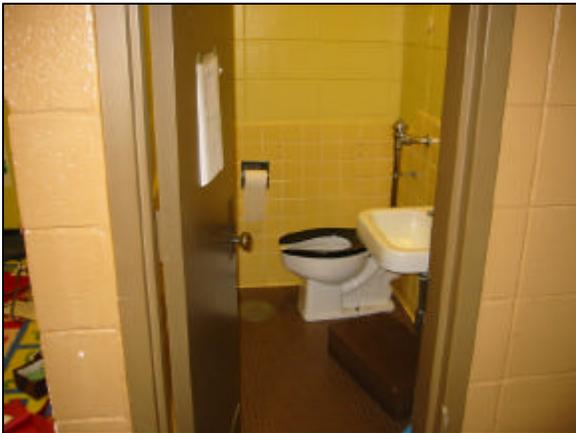
**ADA Non-compliant Toilet**

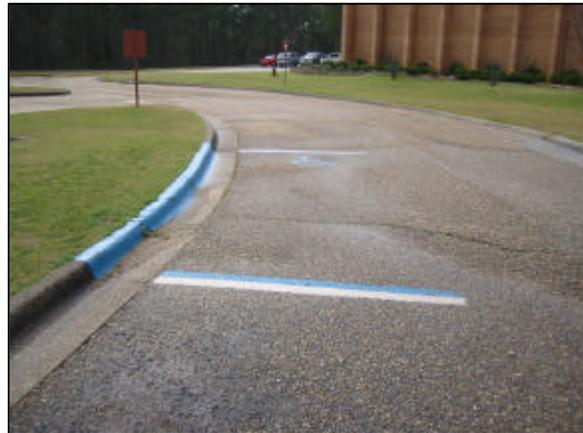
**ADA Non-compliant Parking**

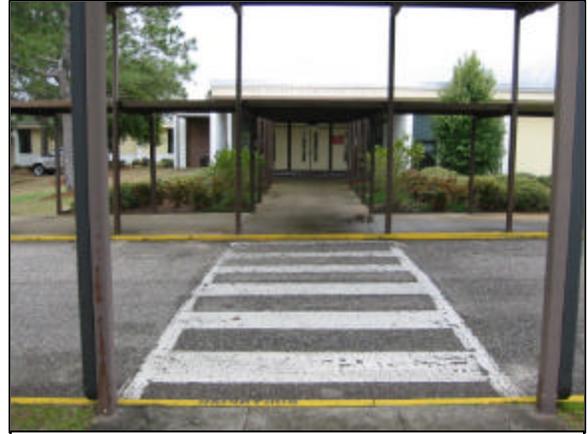
**Photo 2: ADA Non-compliant Path of Travel**

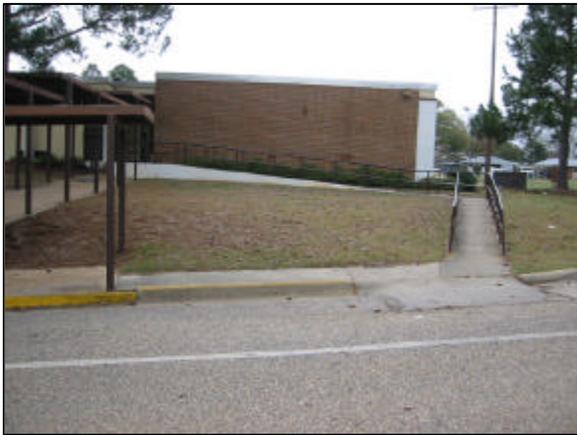
**Photo 3: ADA Non-compliant Ramp**

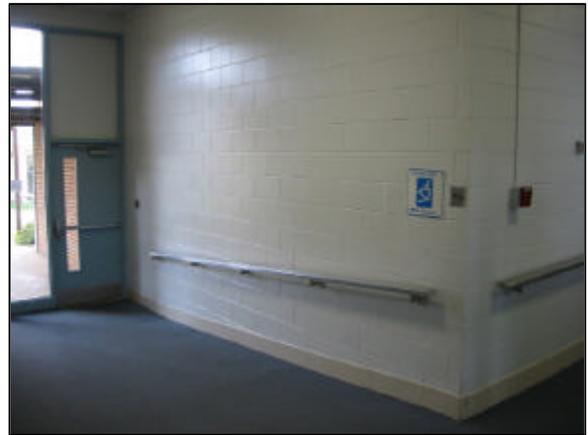
**Photo 4: ADA Non-compliant Interior Ramp**

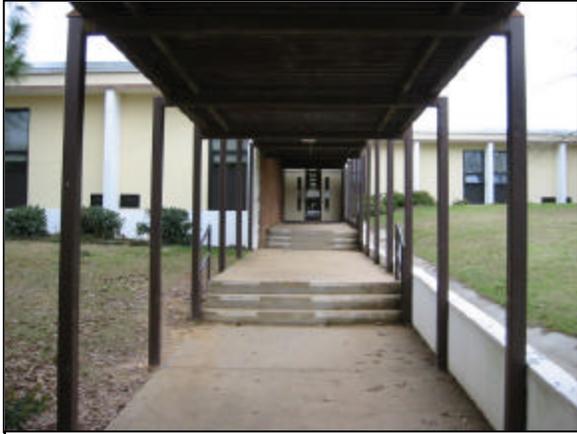
**Photo 5: ADA Non-compliant Exit/Entrance**

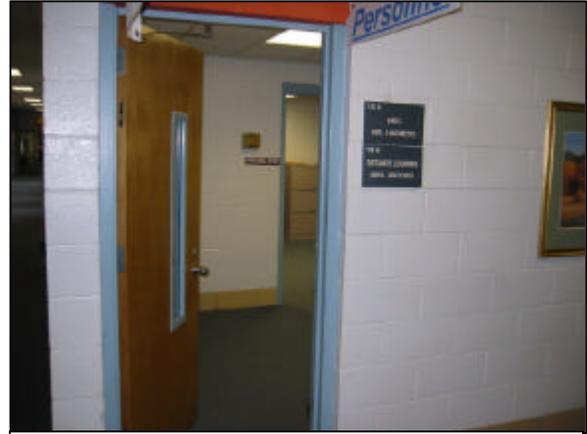
**Photo 6: ADA Non-compliant Door and Signage**

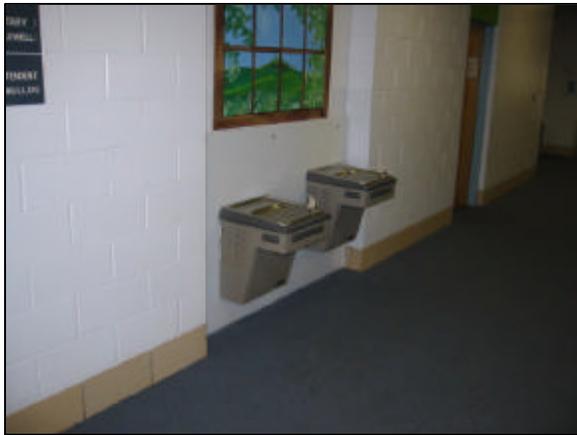
**Photo 7: ADA Non-compliant Drinking Fountains**

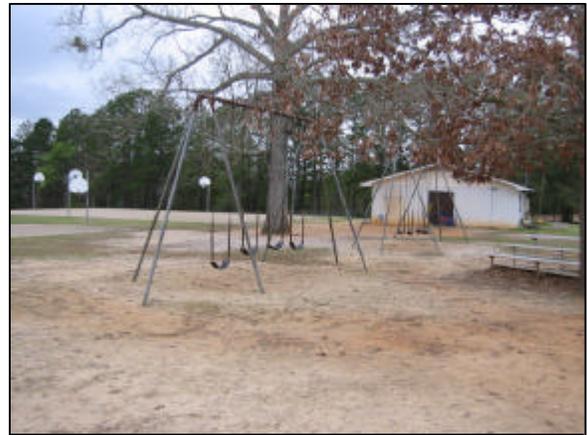
**Photo 8: ADA Non-compliant Play Area**

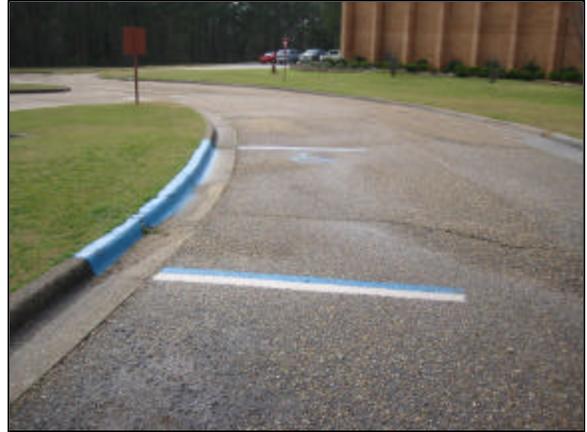
**Photo 2: ADA Non-compliant Parking**

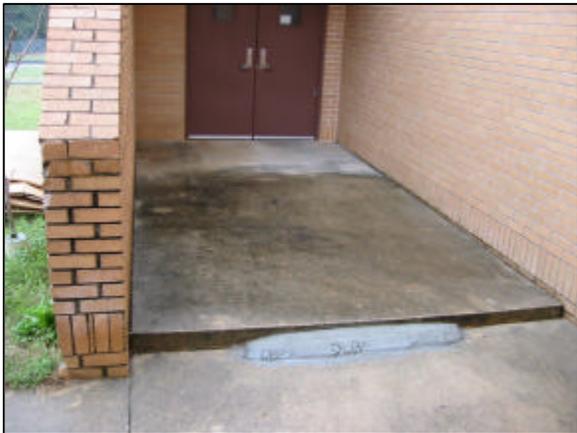
**Photo 3: ADA Non-compliant Exit/Entrance**

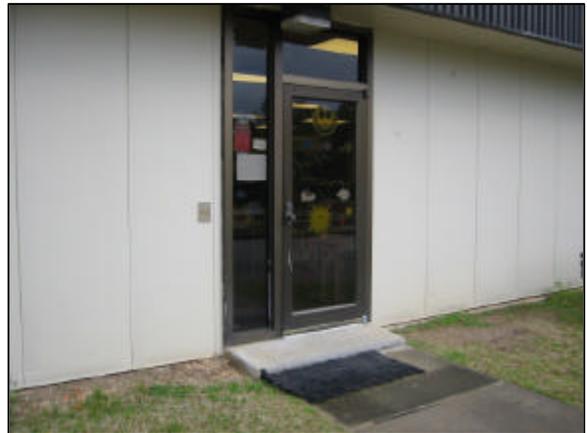
**Photo 4: ADA Non-compliant Exit Entrance**

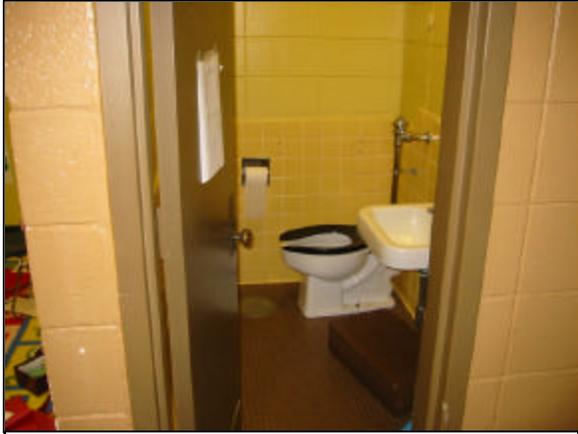
**Photo 5: ADA Non-compliant Toilet**

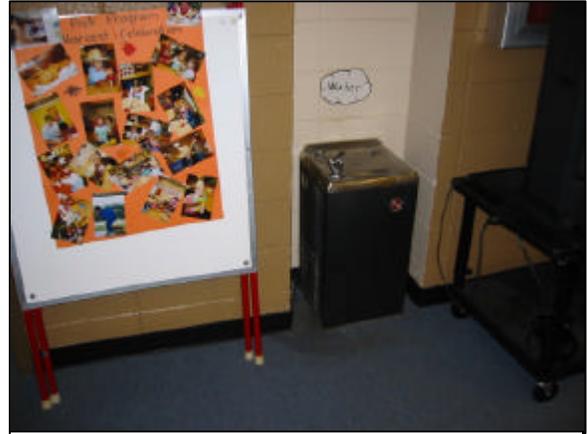
**Photo 6: ADA Non-compliant Drinking Fountain**

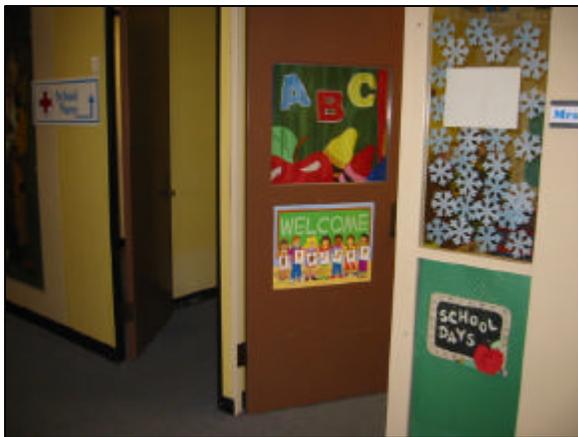
**Photo 7: ADA Non-compliant Doors and Signage**

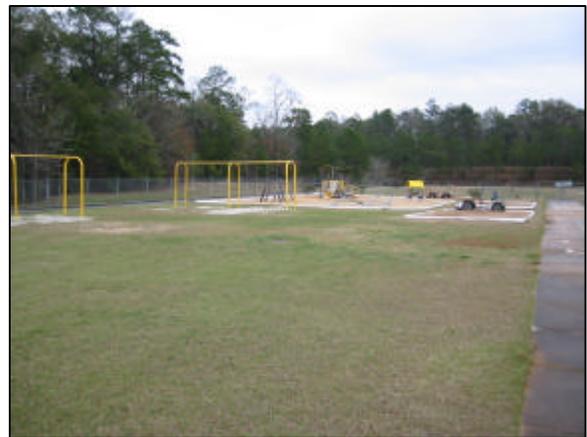
**Photo 8: ADA Non-compliant Play Area**
