# DDESS Facility Transfer Study Facility Condition Report (Final)

## Robins Air Force Base, Georgia

December 10, 2003

**ROBINS AIR FORCE BASE, GEORGIA  
ROBINS ELEMENTARY SCHOOL  
PROPERTY CONDITION REPORT**

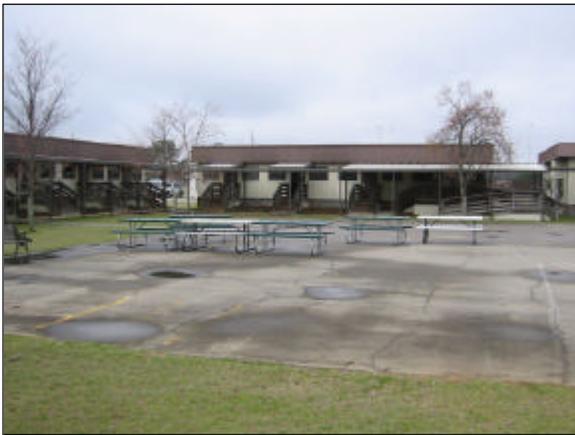
**Damaged Blacktop between Portables**

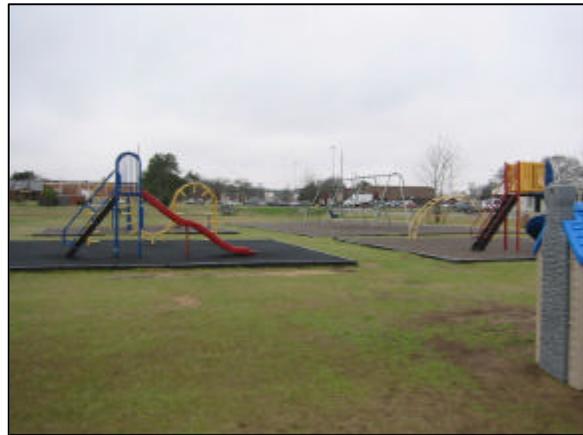
**ADA Non-compliant Play Area**

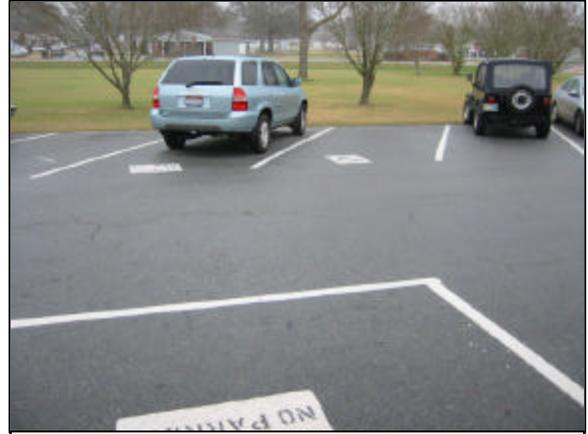
**Photo 2: ADA Non-compliant Parking**

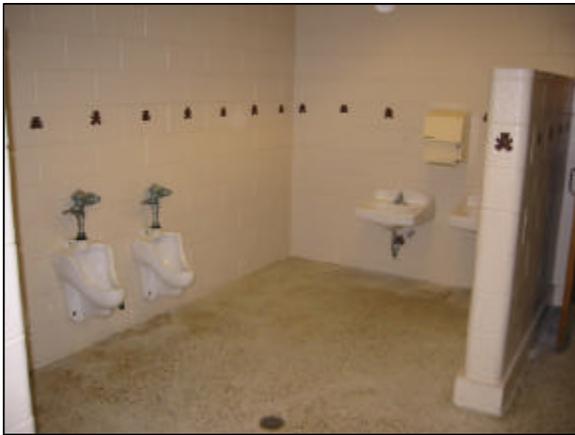
**Photo 3: ADA Non-compliant Toilet**

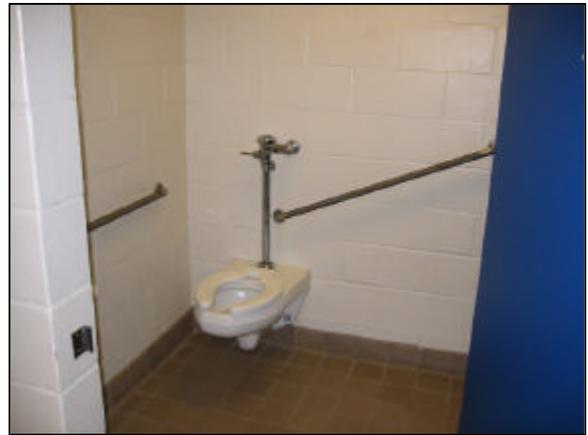
**Photo 4: ADA Non-compliant Toilet**

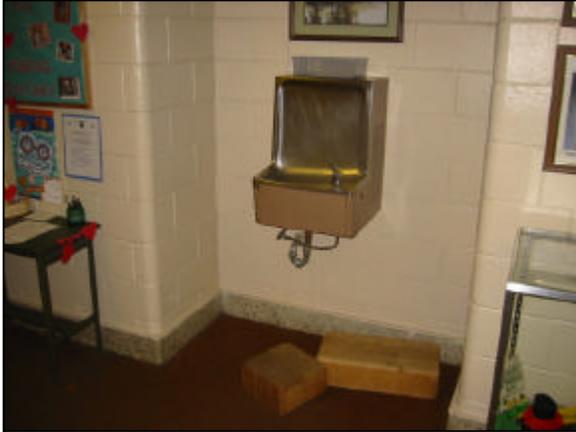
**Photo 5: ADA Non-compliant Drinking Fountain**

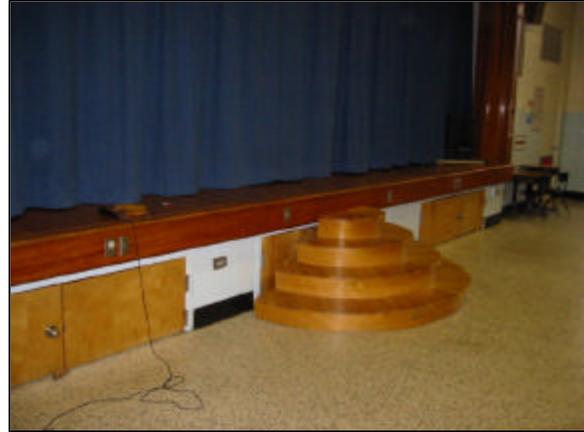
**Photo 6: ADA Non-compliant Stage Access**

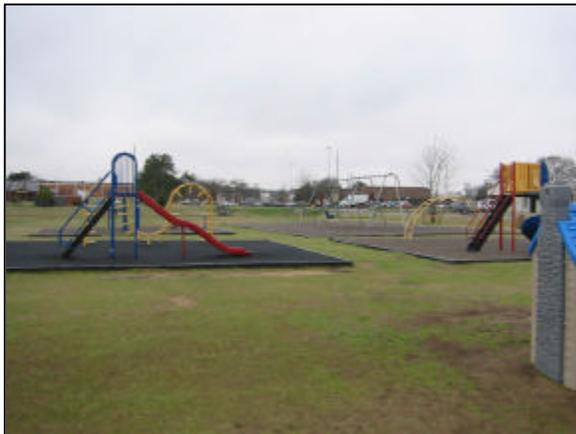
**Photo 7: ADA Non-compliant Play Area**

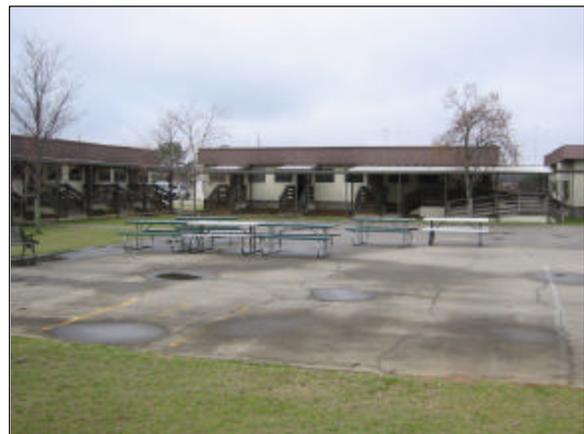
3.2.3 Flatwork
X		<p>Concrete and asphaltic concrete walkways are in fair to poor condition, as pictured in the appendix. Corrective action is required.</p> <p>Walkways from drop off areas and between the main building and freestanding buildings are protected by covered structures in good condition. Corrective action is not required.</p>

**Photo 8: Damaged Blacktop between Portables**
