DDESS Facility Transfer Study Facility Condition Report (Final)

Fort Campbell, Kentucky

December 10, 2003

FORT CAMPBELL SCHOOLS
FORT CAMPBELL, KENTUCKY
PROPERTY CONDITION REPORT

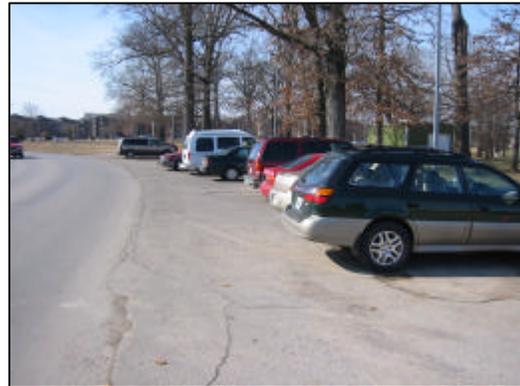
Paving in Poor Condition

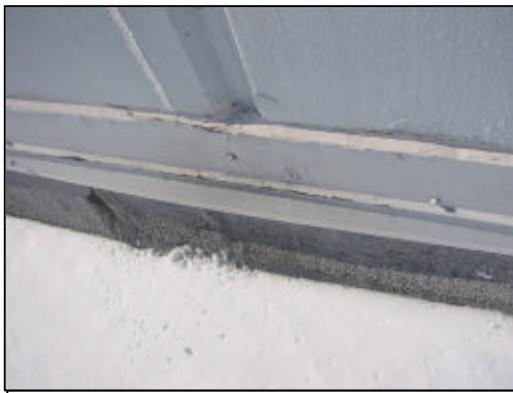
Roof Flashing Problem

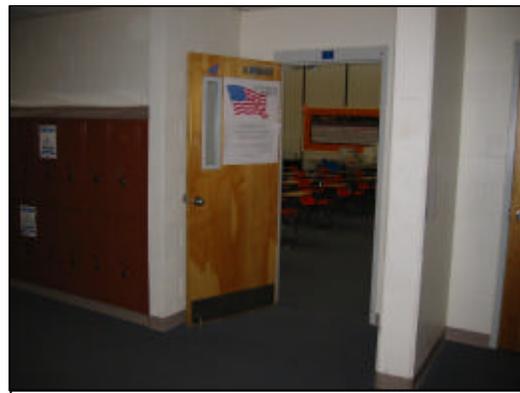
Non-compliant Door

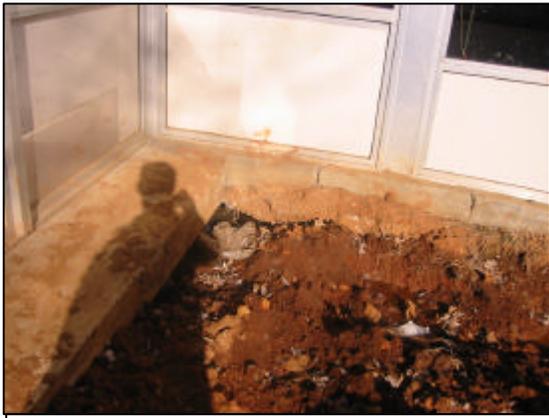
Foundation Problem at Broken Water Pipe

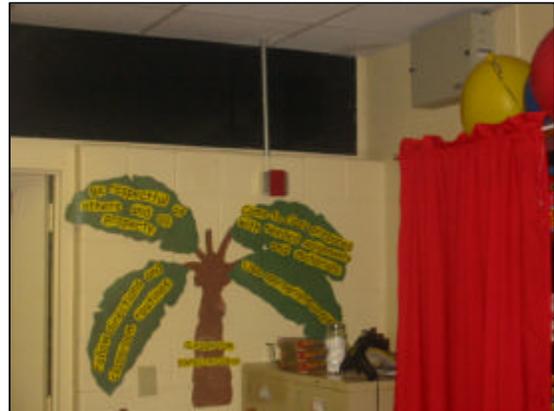
Typical Classroom with Horn but no Visual Alarm

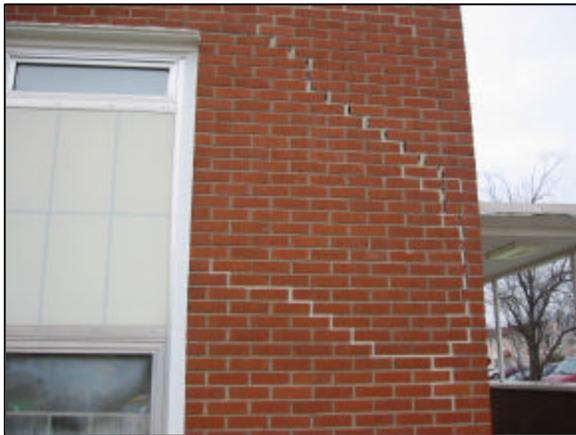
Damaged Brick

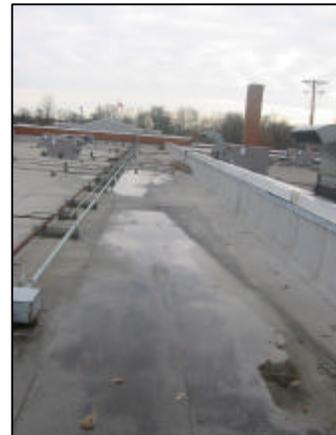
Roof Ponding

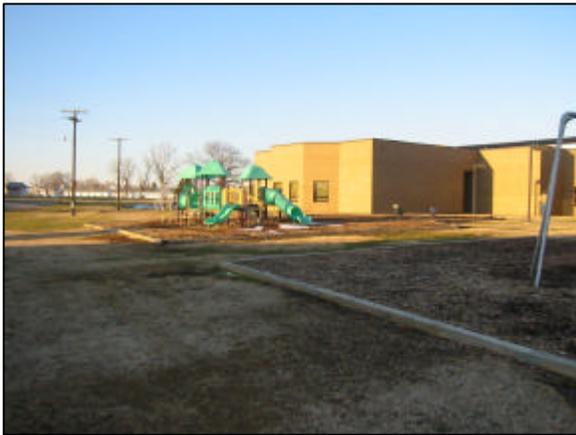
Non-compliant Play Area

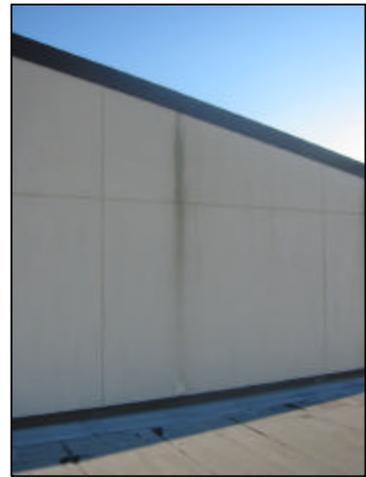
History of Roof Leak Here

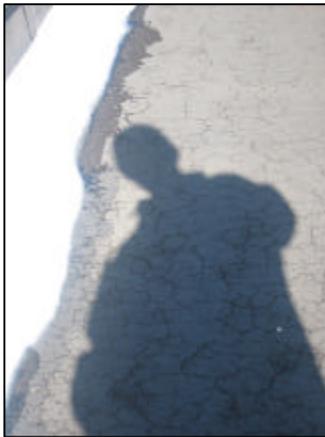
Roof Deterioration

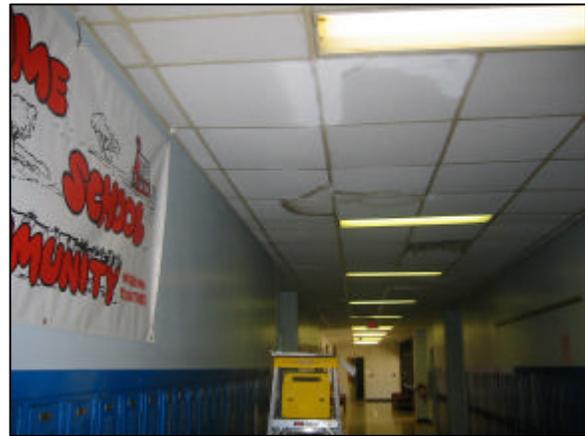
Bad Ceiling and Lighting

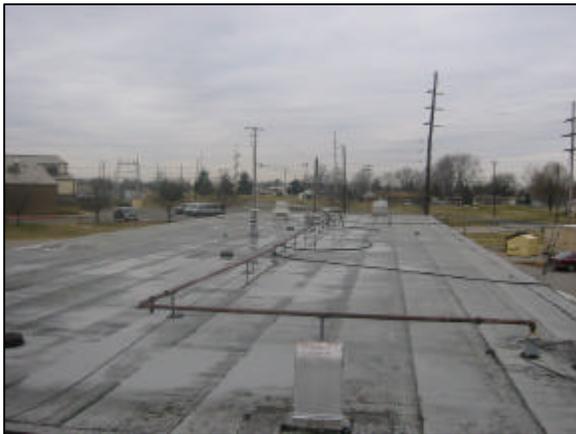
Roof Ponding and Deterioration

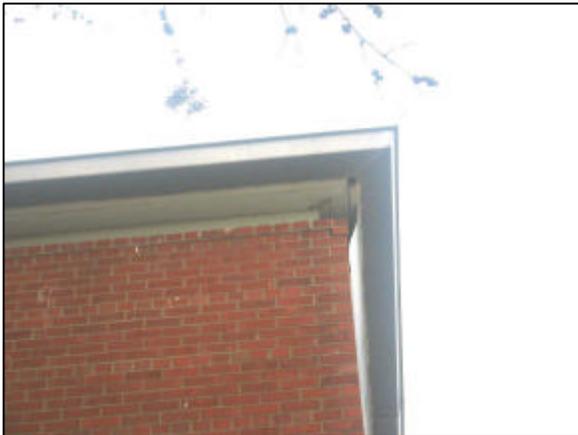
Damaged Brick Veneer

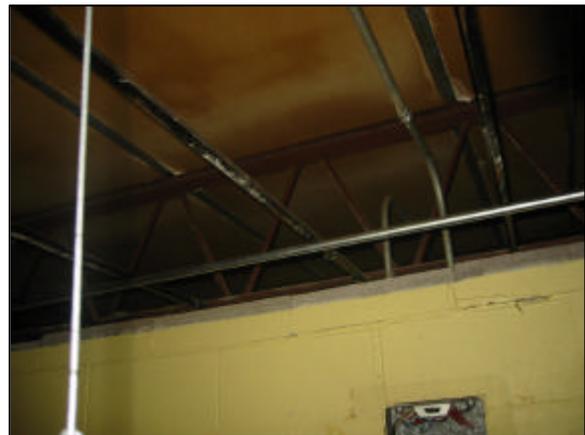
Corridor Walls not to Deck

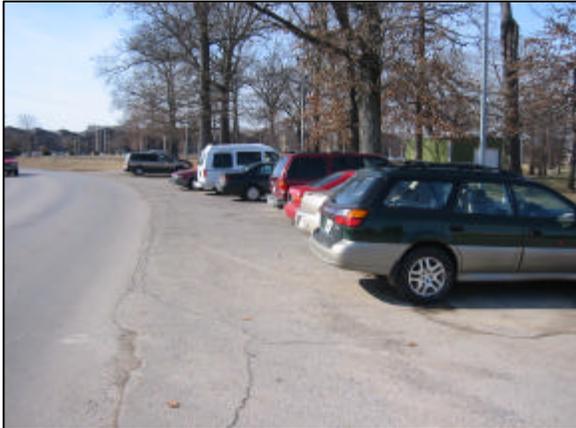
Photo 3: Paving in Poor Condition

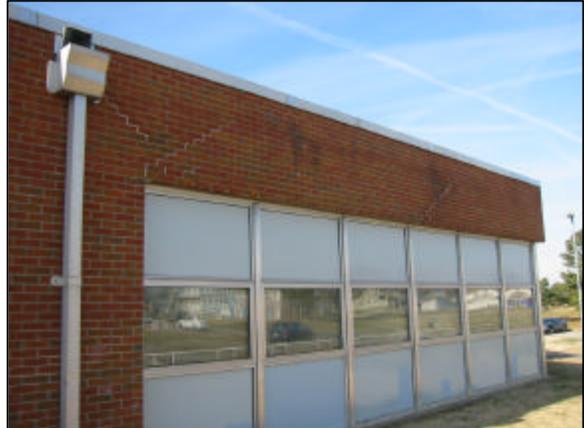
Photo 4: Brick Crack

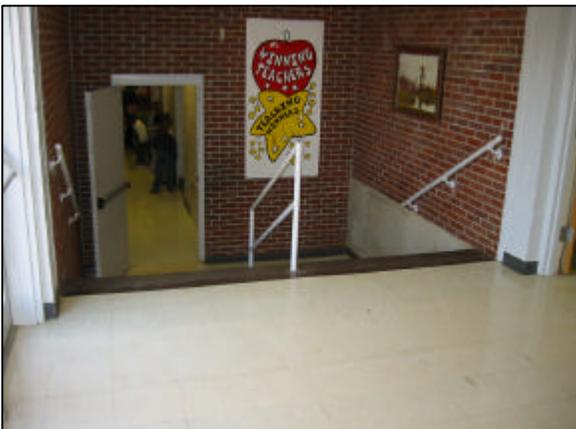
Photo 5: Non-compliant Vertical Circulation

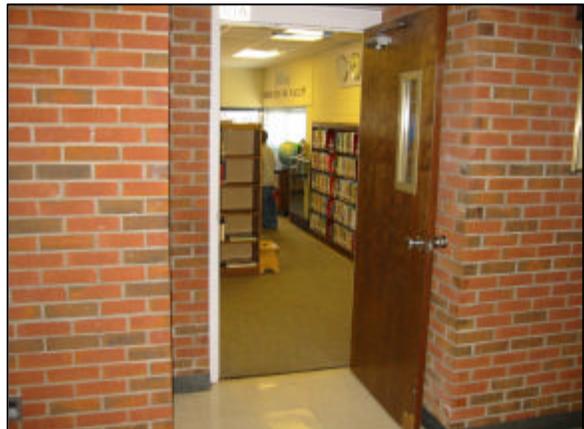
Photo 6: Non-compliant Door and Hardware

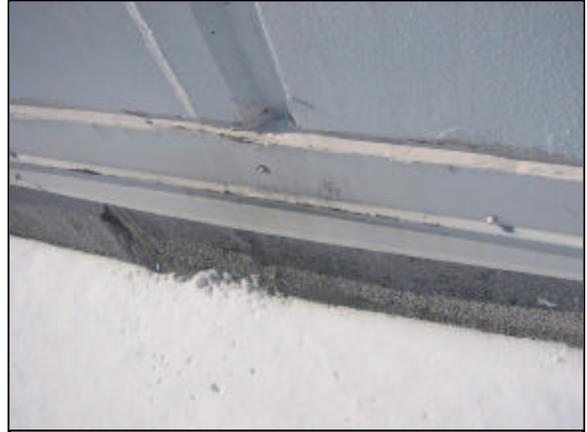
Photo 2: Roof Leak at Flashing

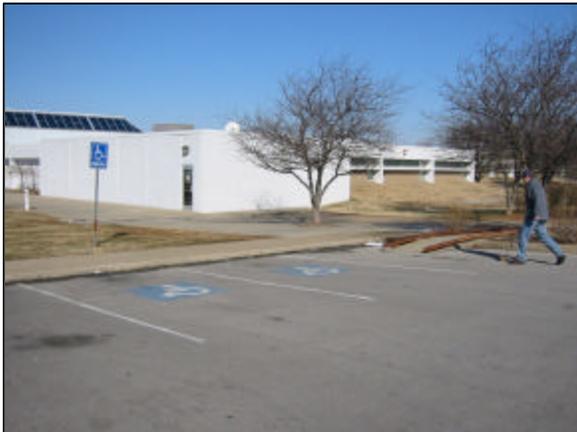
Photo 3: Access thru Drive Lane

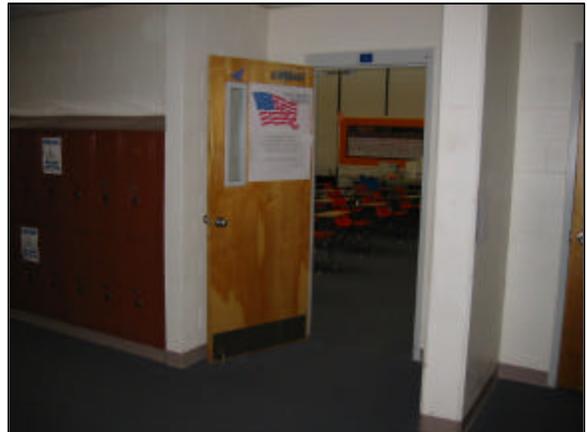
Photo 4: Non-compliant Door

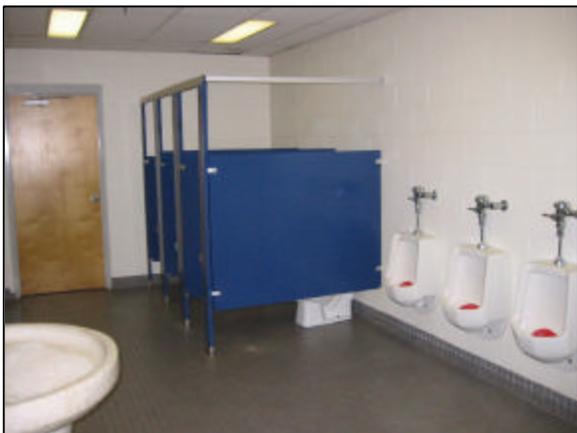
Photo 5: Non-compliant Fixture

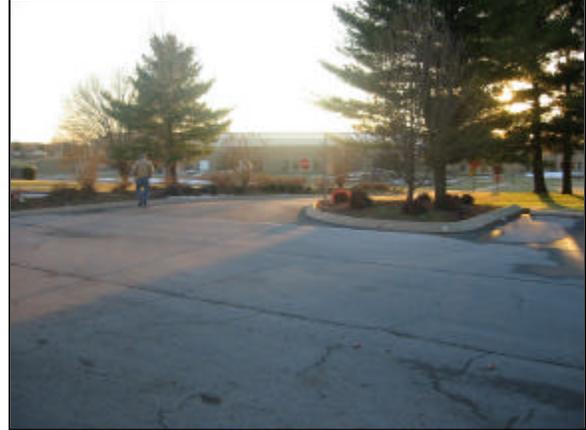
Photo 2: Pavement in Poor Condition

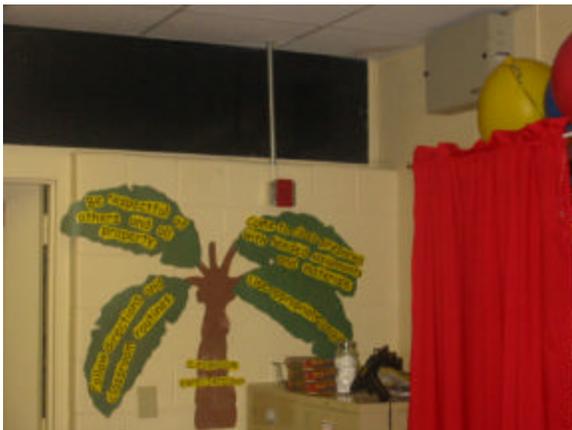
Photo 3: Provide Strobe with the Horn, Life Safety

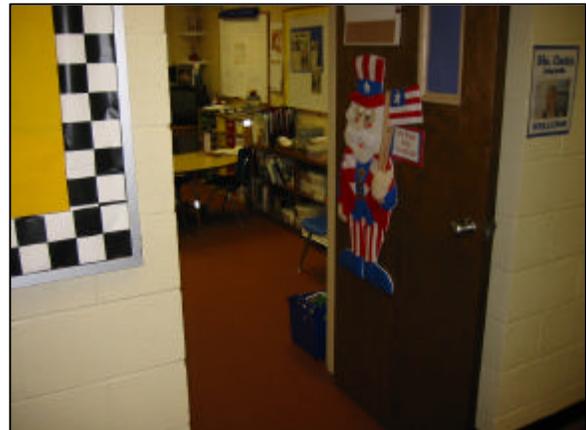
Photo 4: ADA Non-compliant Door and Signage

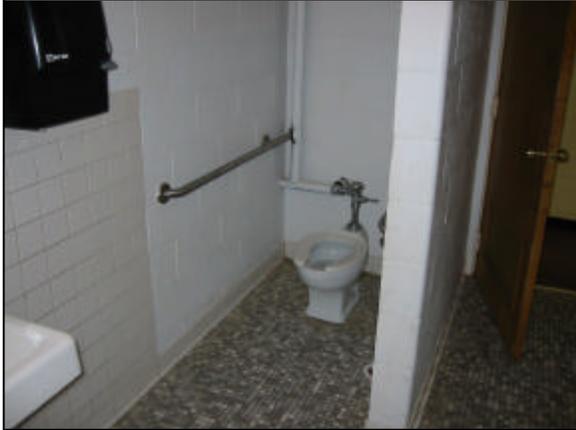
Photo 5: ADA Non-compliant Toilet and Door

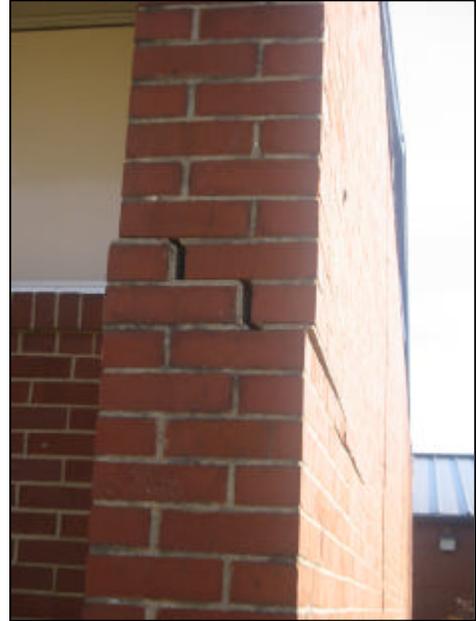
Photo 6: Cracked Masonry from Foundation Shift

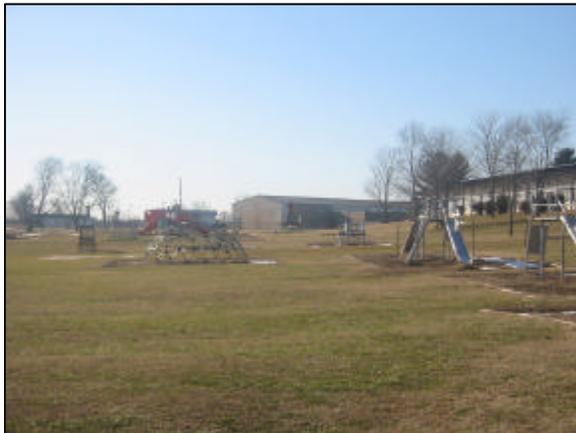
Photo 7: ADA Non-compliant Play Area

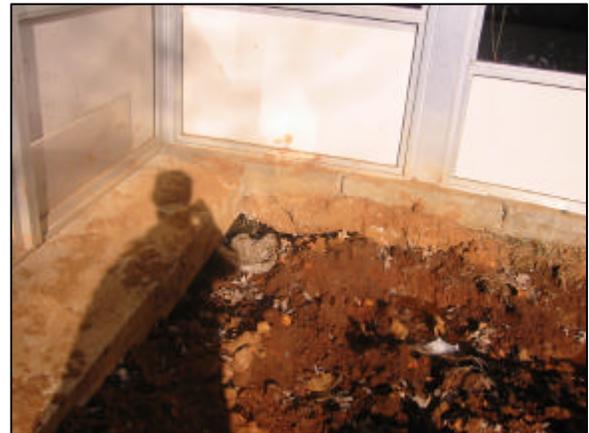
Photo 8: Broken Water Pipe, Damage to Grade Beam

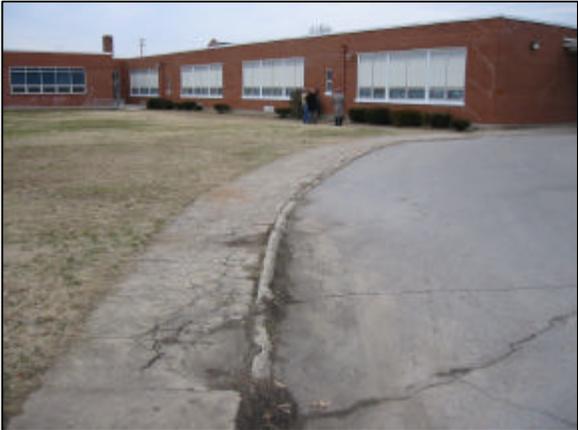
Photo 2: Damaged Walkway and Pavement

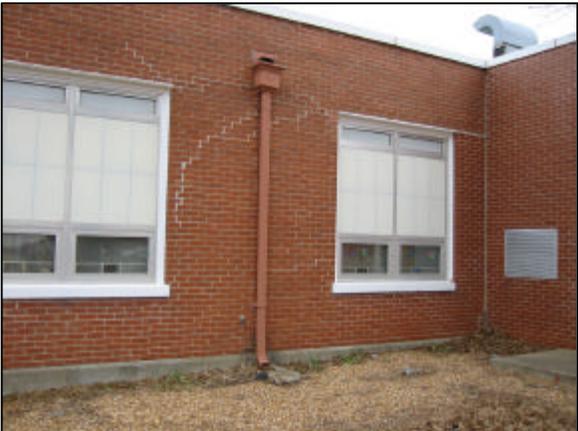
Photo 3: Damaged Face Brick Masonry

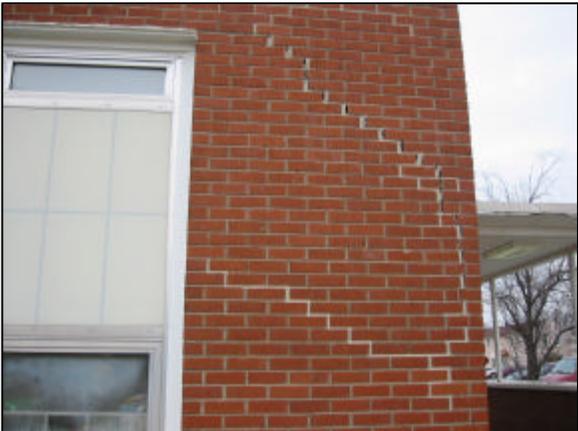
Photo 4: Damaged Face Brick Masonry

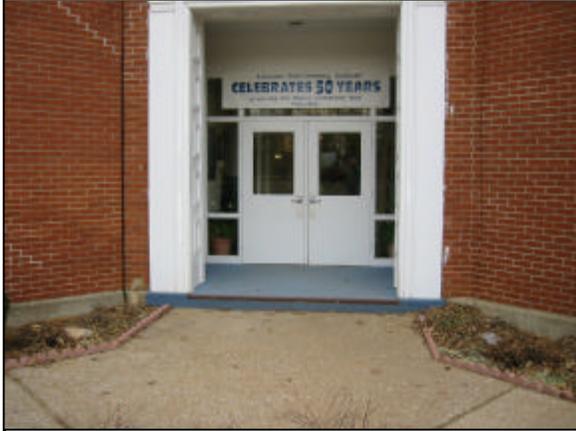
Photo 5: ADA Non-compliant Entrance

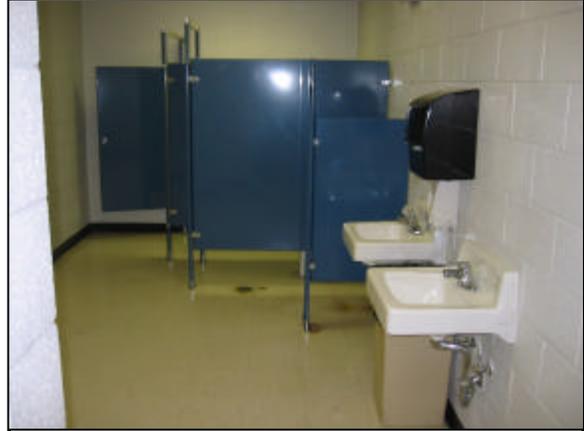
Photo 6: ADA Non-compliant Toilet

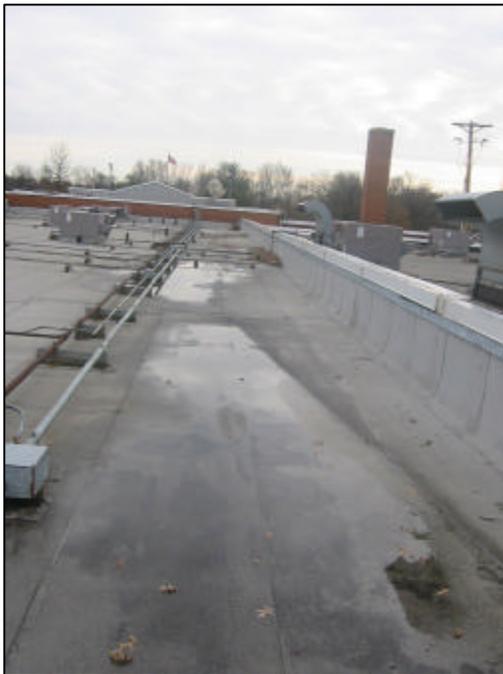
Photo 7: Roof Ponding

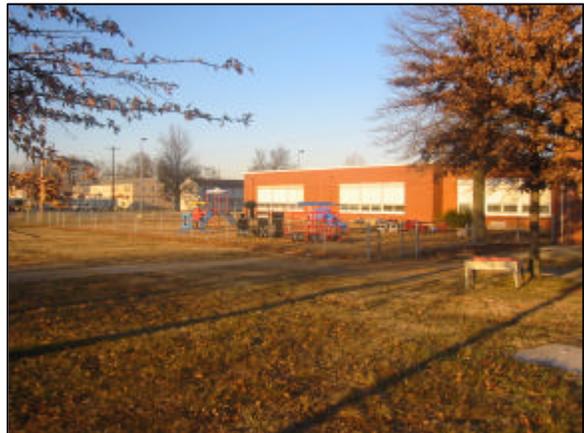
Photo 8: ADA Non-compliant Play Areas

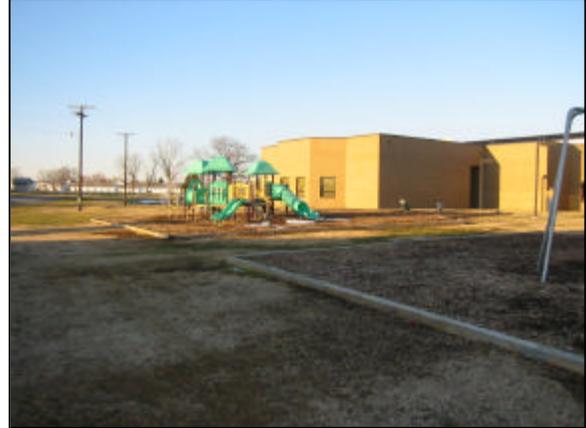
Photo 2: Non-compliant Play Area

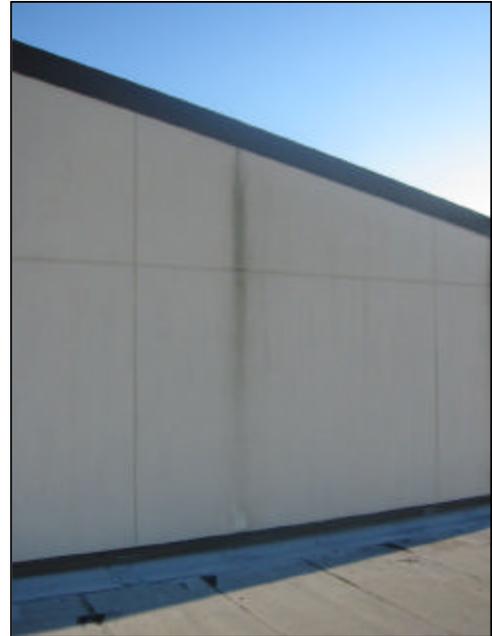
Photo 4: History of Roof Leak Here

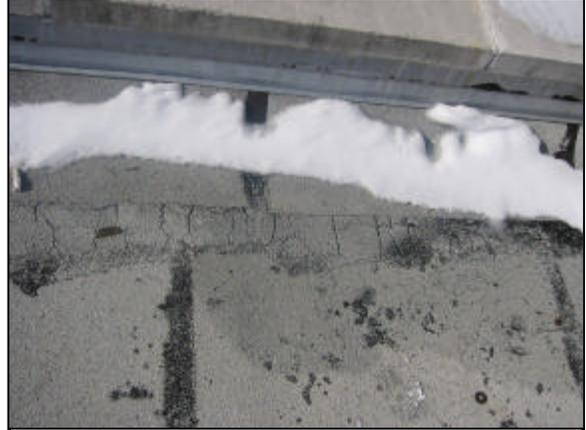
Photo 2: Damaged Roofing

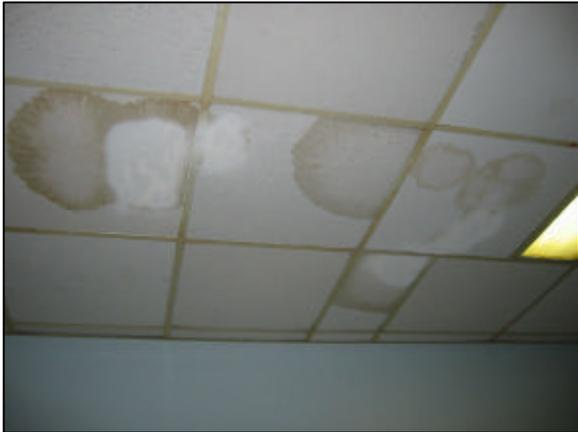
Photo 3: Ceiling Damage from Roof Leak

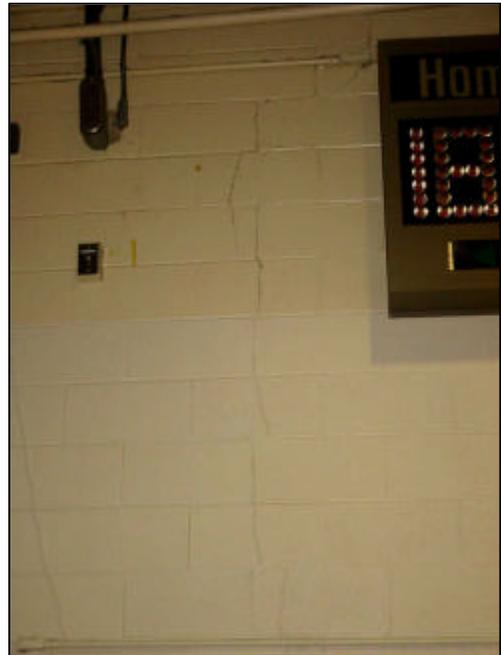
Photo 4: Crack in Wall at Gym

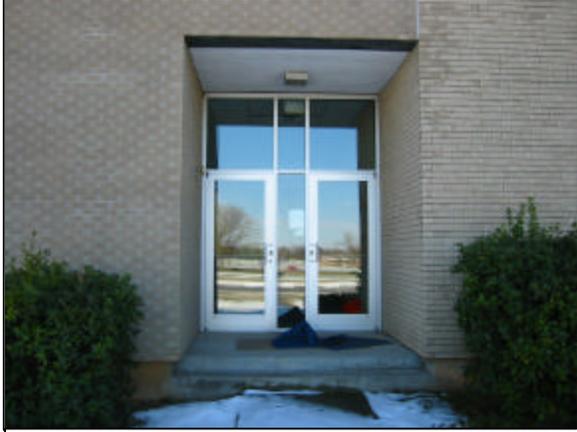
Photo 5: ADA Non-compliant Exit/Entrance

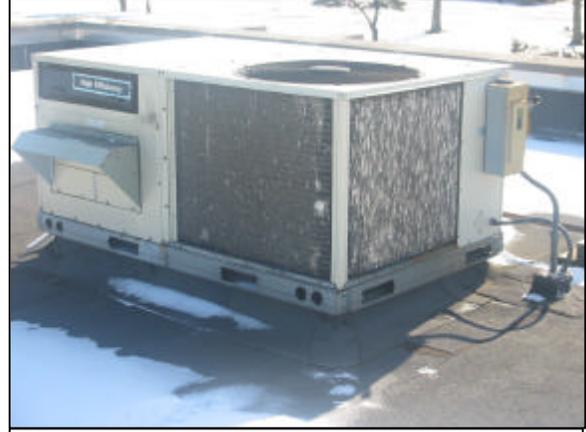
Photo 6: Old Rooftop Unit

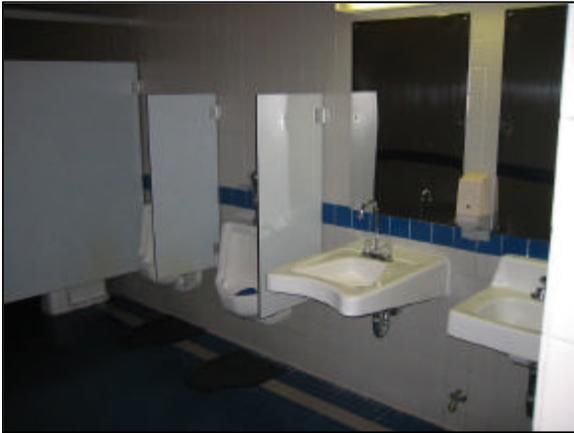
Photo 7: ADA Non-compliant Toilet

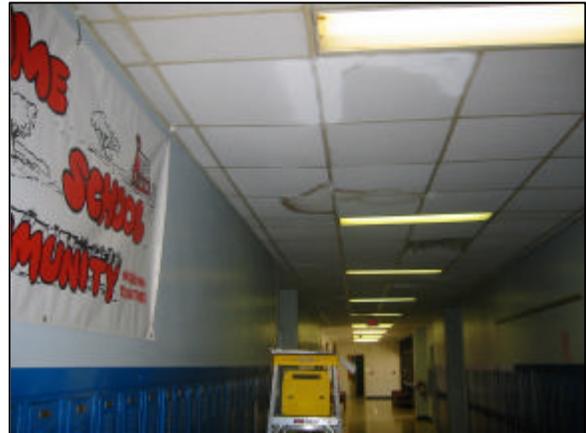
Photo 8: Bad Lighting and Ceiling

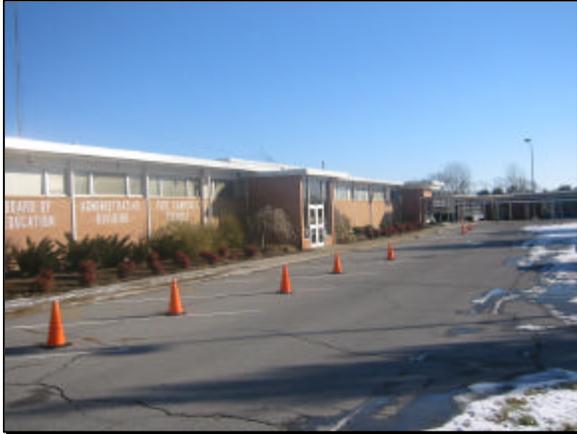
Photo 1: Sign and Damaged Pavement

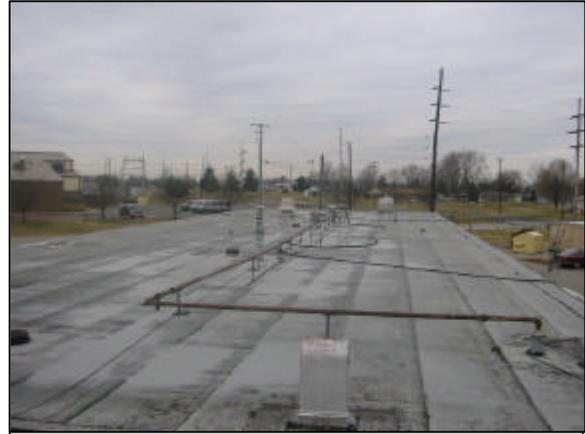
Photo 2: Roof Ponding and Deterioration

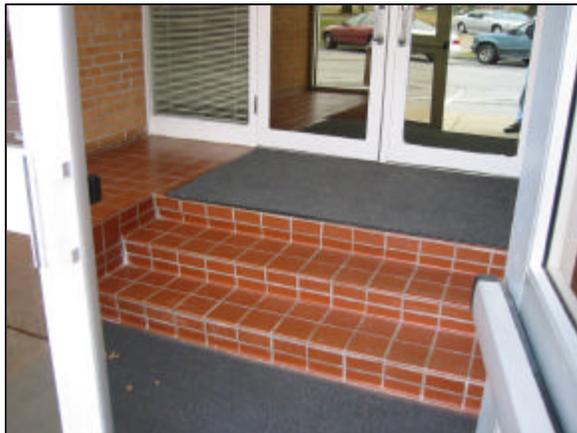
Photo 3: ADA Non-compliant Entrance

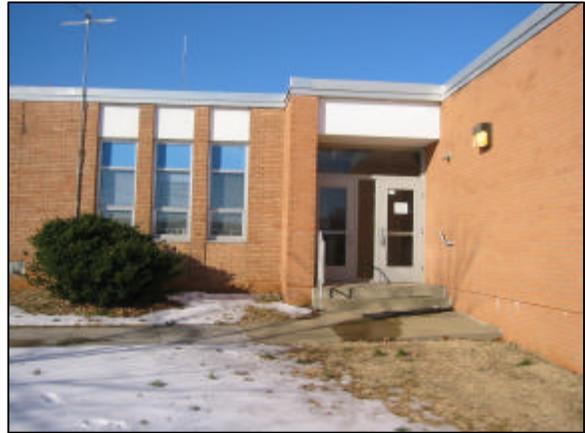
Photo 4: ADA Non-compliant Exit/Entrance

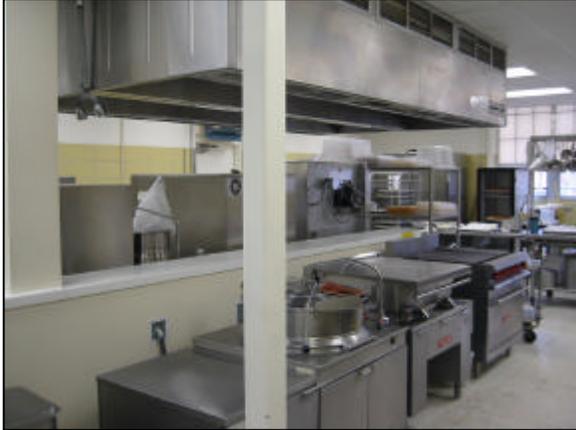
Photo 5: Non-compliant Kitchen Hood Coverage

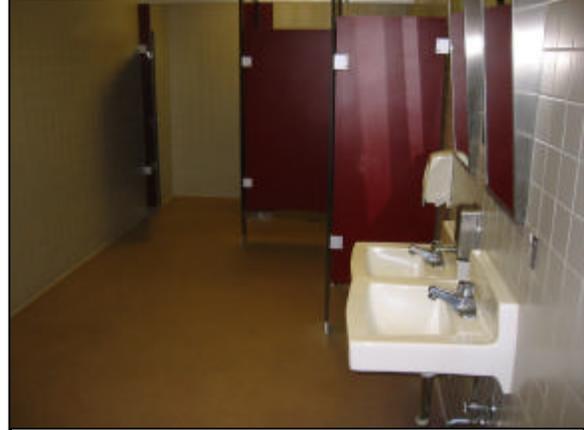
Photo 6: ADA Non-compliant Toilet

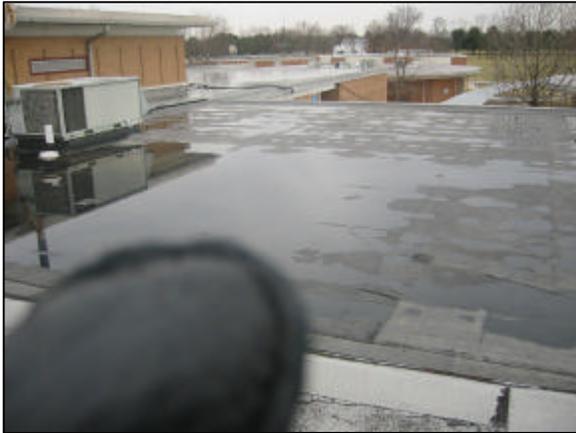
Photo 7: Needs New HVAC Unit

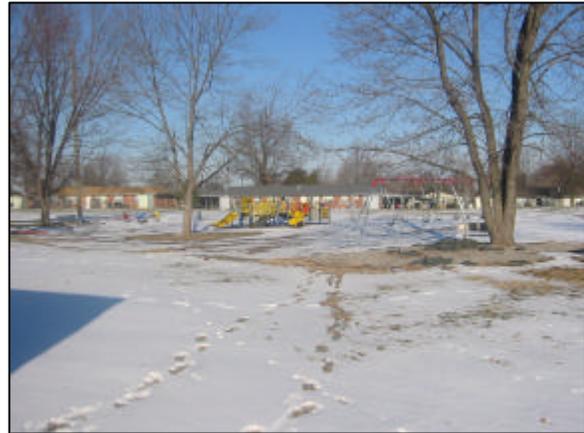
Photo 8: ADA Non-compliant Play Areas

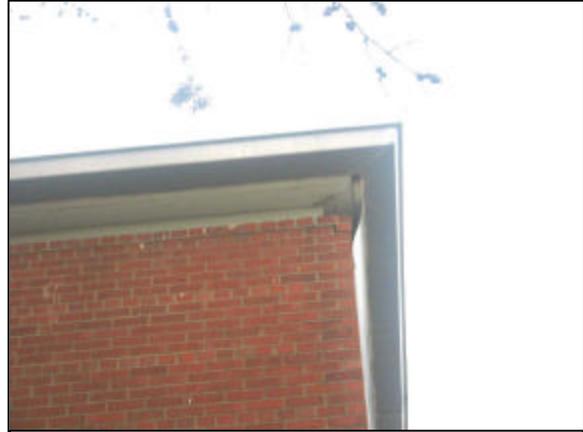
Photo 2: Damaged Brick Veneer

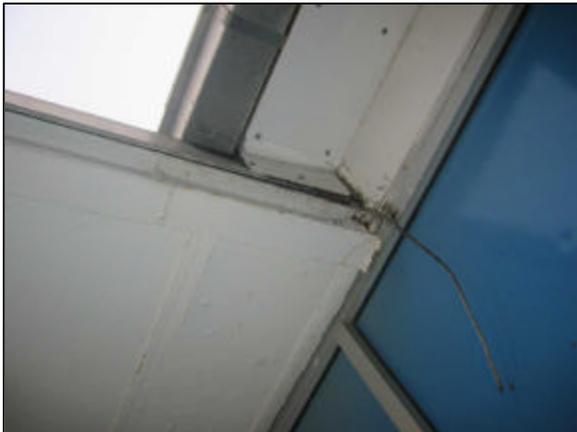
Photo 3: Canopy Beam Connection

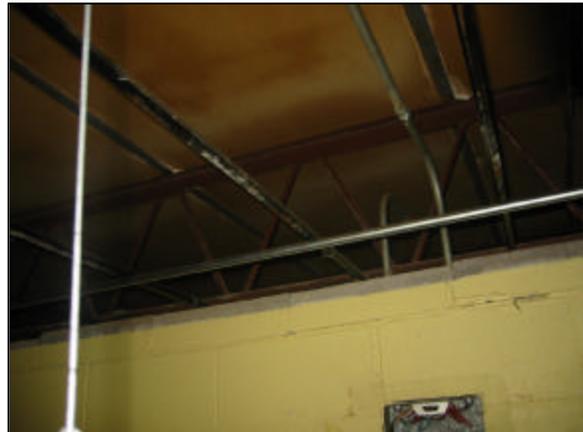
Photo 4: Corridor Walls not to Deck

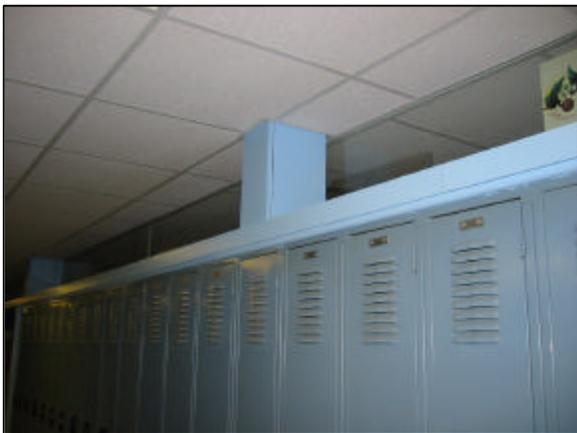
Photo 5: Unprotected Corridor Glass

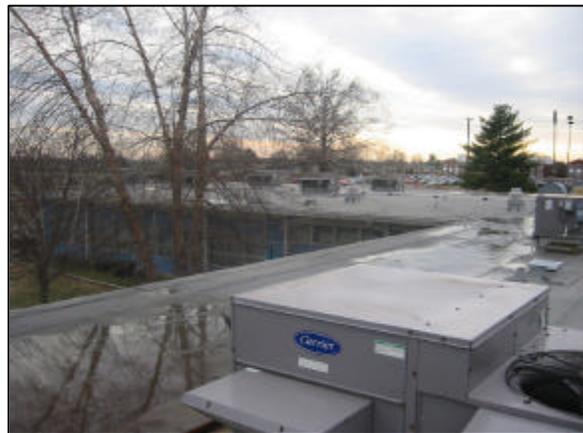
Photo 6: Roof Ponding
