DDESS Facility Transfer Study Facility Condition Report (Final)

Fort Jackson, South Carolina

December 10, 2003

FORT JACKSON SCHOOLS
FORT JACKSON, SOUTH CAROLINA
PROPERTY CONDITION REPORT

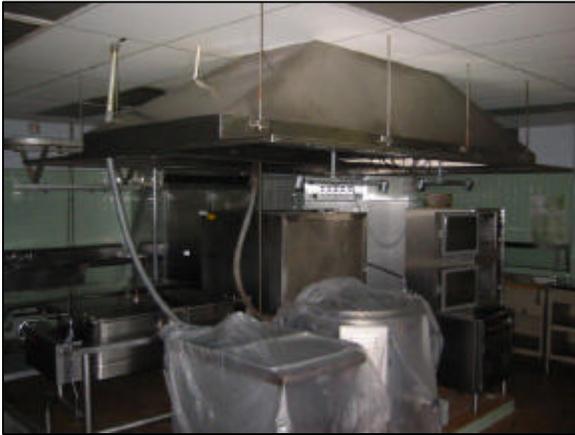
Non-complying Kitchen Hood

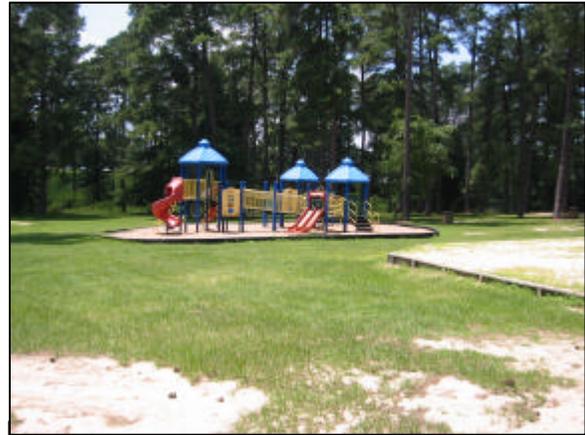
Non-complying Play Surface

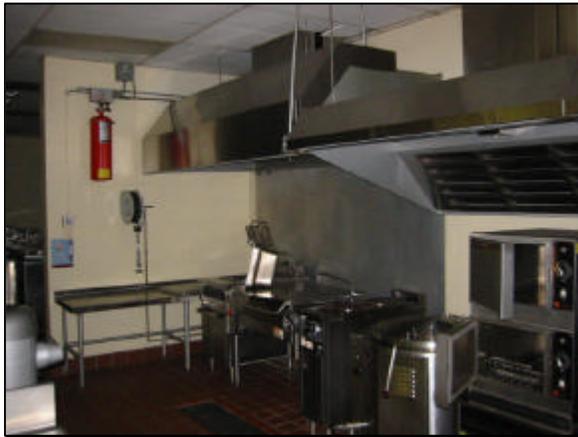
Non-complying Kitchen Hood

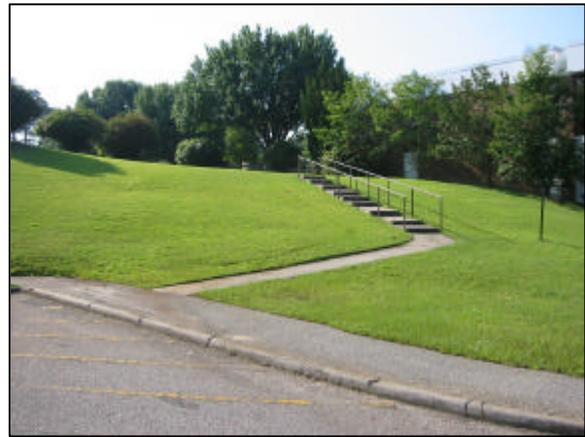
Non-accessible Route from Parking

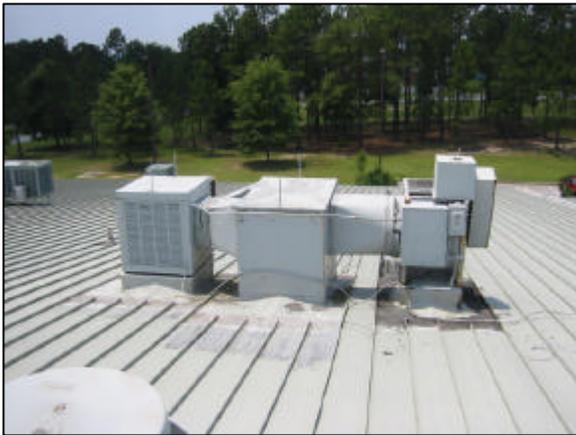
Roof Leaks at Mech. Units

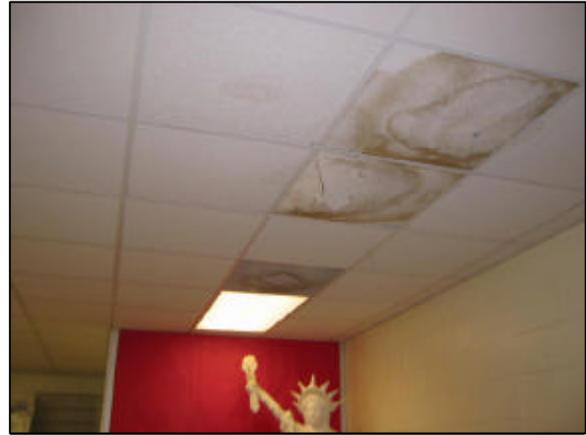
Roof Leaks and Poor Lighting

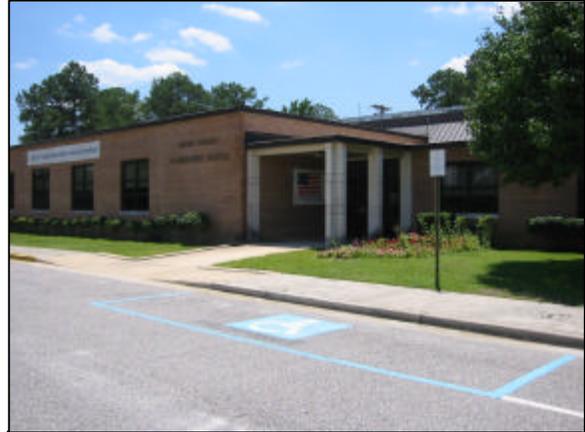
Photo 2: No Compliant ADA Parking

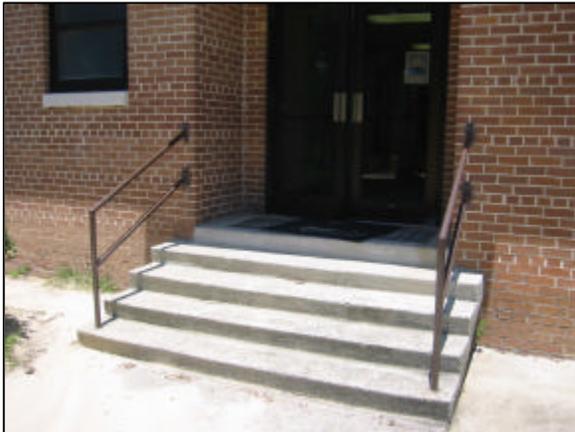
Photo 3: Non ADA Complying Exit

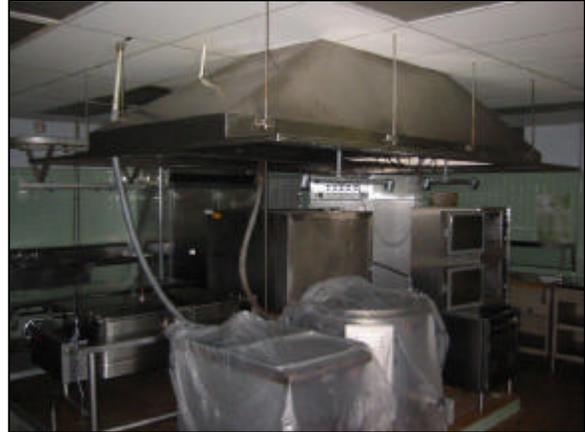
Photo 4: Non-complying Kitchen Hood

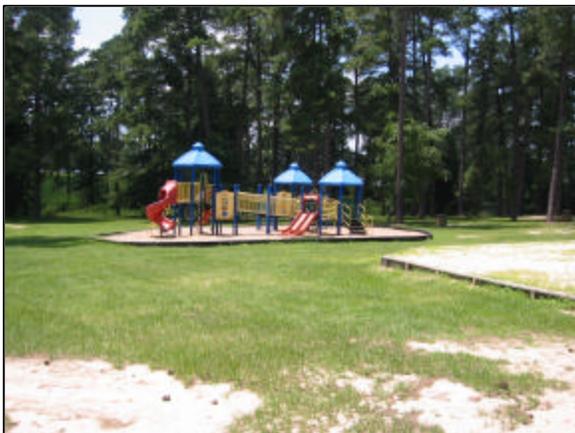
Photo 5: Non-compliant Play Surface

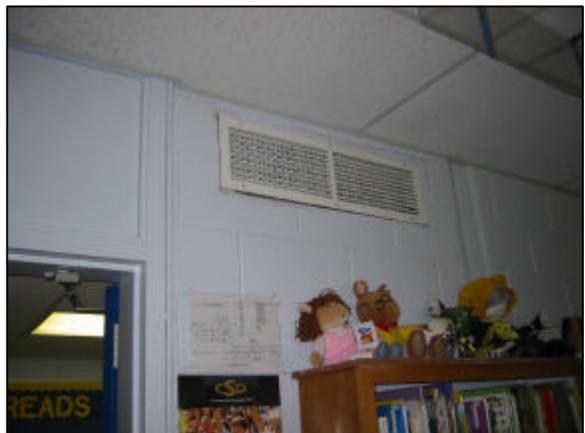
Photo 6: Non-compliant Transfer Grille

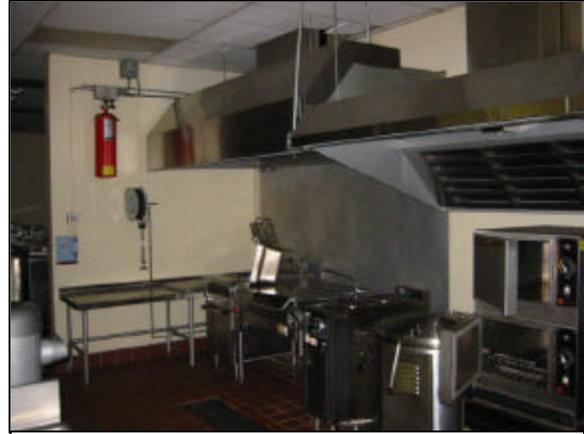
Photo 2: Kitchen Hood Non-compliant

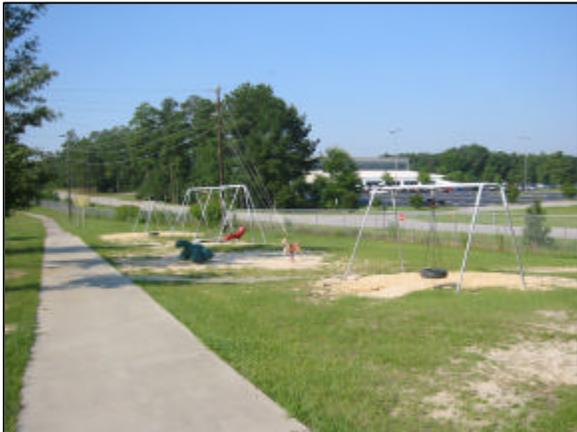
Photo 3: ADA Non-compliant Play Surface

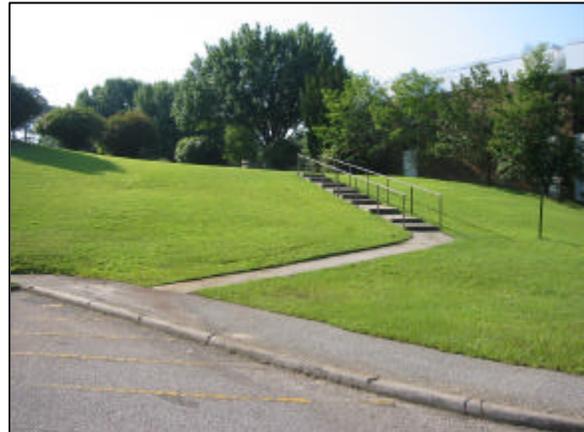
Photo 4: Non-accessible Route from Parking

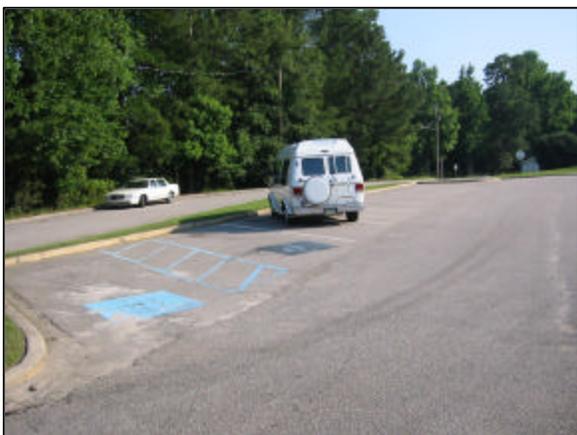
Photo 5: ADA Route in Traffic

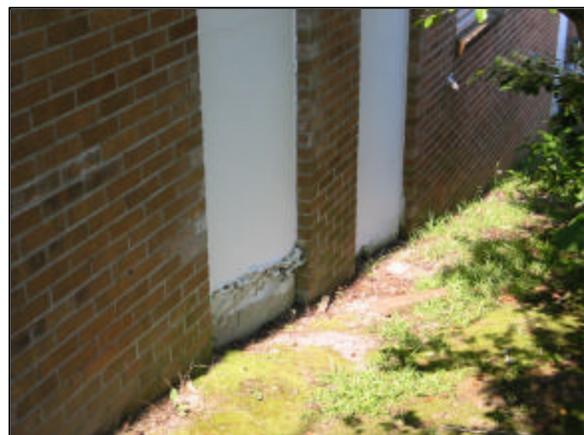
Photo 6: Damaged Stucco

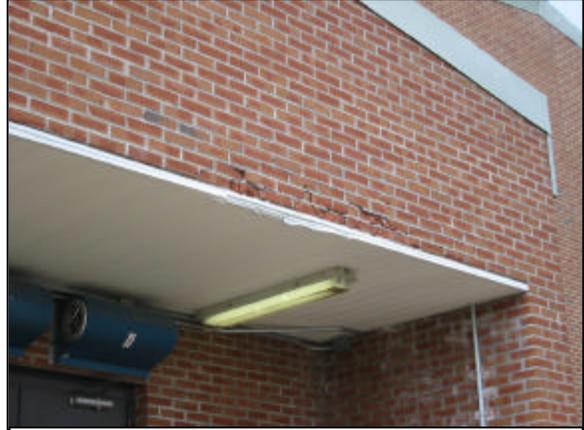
Photo 2: Damaged Brick Veneer

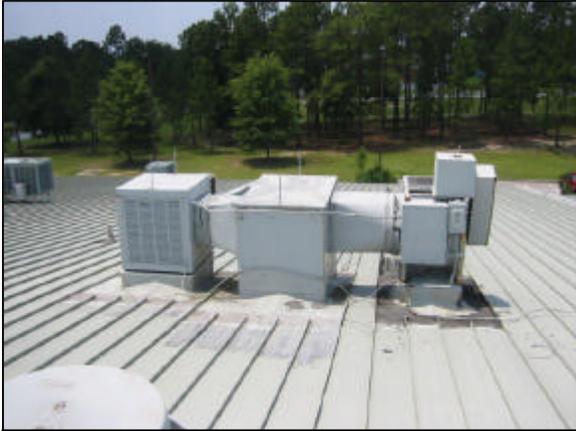
Photo 3: Roof Leaks at Condensers

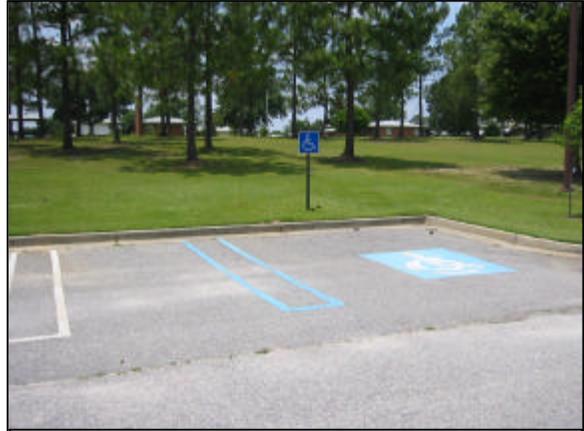
Photo 4: ADA Route in Drive Lane

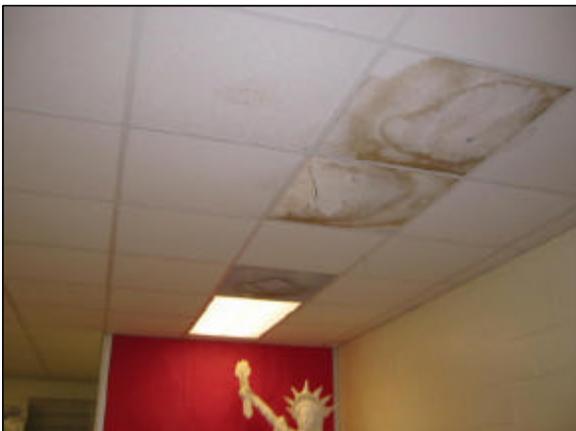
Photo 5: Roof Leaks and Poor Lighting

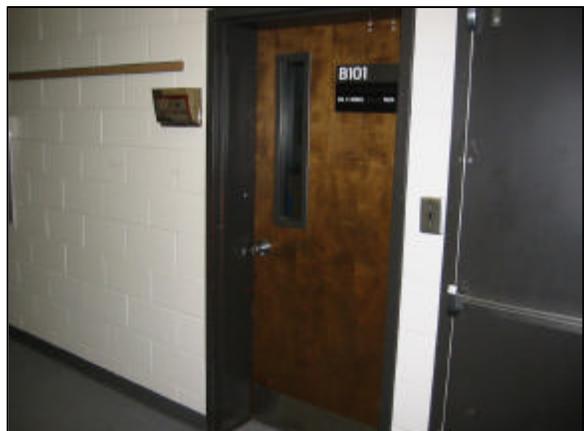
Photo 6: Non-compliant Door Hardware
