# DDESS Facility Transfer Study Facility Condition Report (Final)

## Laurel Bay Marine Corps Base, South Carolina

December 10, 2003

LAUREL BAY SCHOOLS  
LAUREL BAY, SOUTH CAROLINA  
PROPERTY CONDITION REPORT

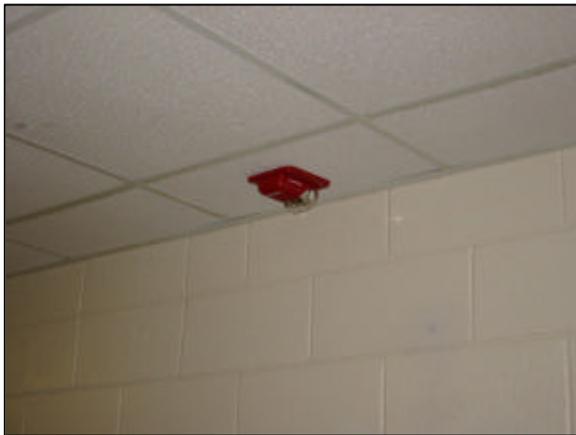
**Life Safety Code Non-compliant**

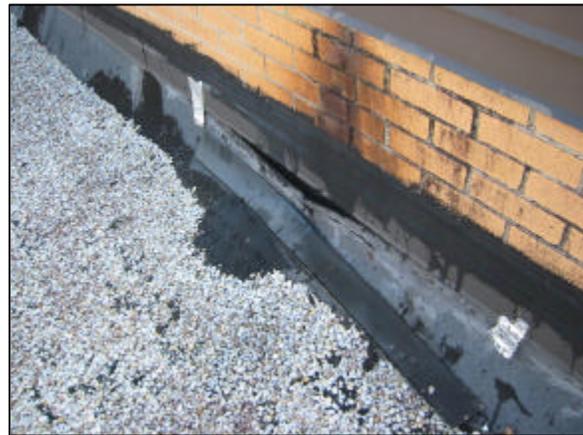
**Repair/Replace Roofing and Flashing**

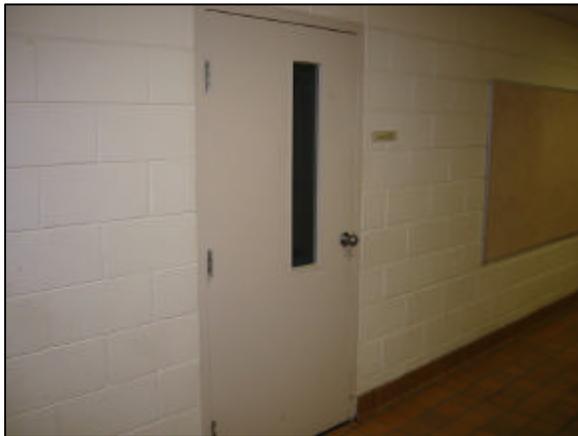
**Non-compliant Door**

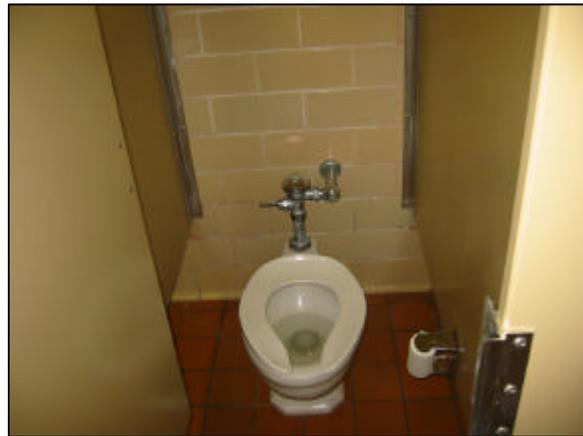
**Non-compliant Toilet**

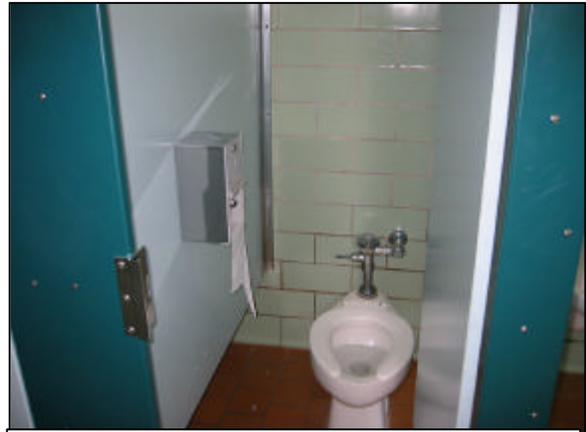
**Photo 2: Non-complying Toilet**

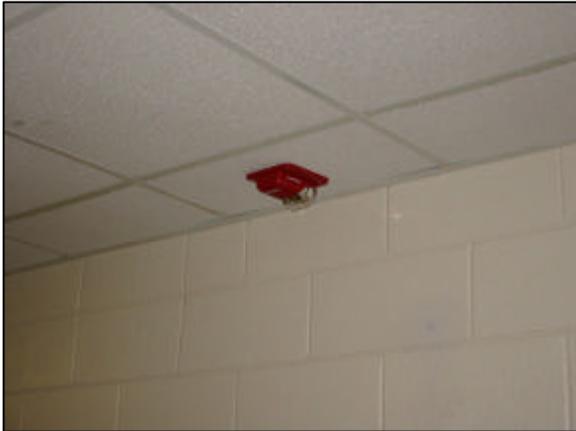
**Photo 3: Life Safety Code Violation**

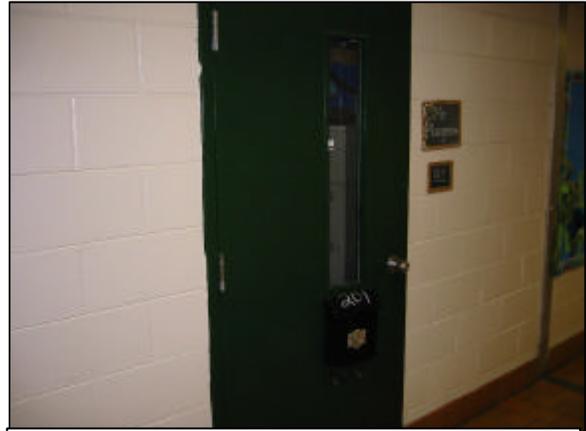
**Photo 4: Non-complying Door Hardware**

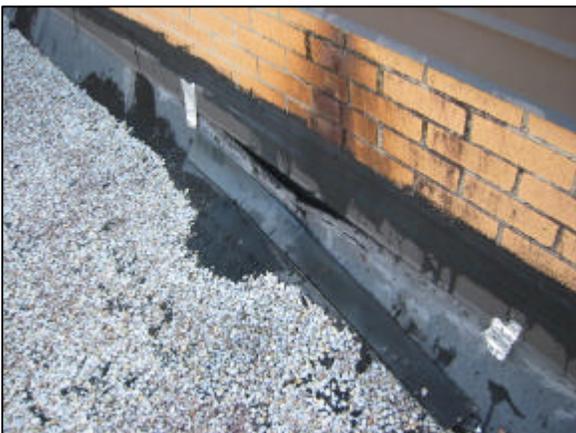
| I | LT | Reference |
|---|---|---|
| X | X | Low slope gravel surface built-up roofing is located on the original building and is in poor condition. Major leaks are evident. Corrective action is required.<br><br>Low slope modified bitumen roofing is located on the Media Center addition and is in good condition. Corrective action is not required.<br><br>Sloped pre-finished standing seam metal roofing is located on the classroom/gymnasium addition and is in good condition. Corrective action is not required. |

**Photo 5: Repair/Replace Roofing and Flashing**

| I | LT | Reference |
|---|---|---|
| | X | Flashing, coping, fascia, gutters and downspouts are pre -finished metal in fair condition. Corrective action is required with roofing replacement . |

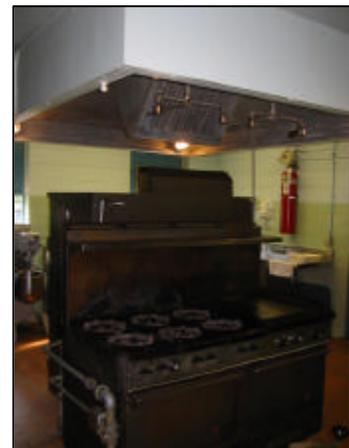
**Photo 6: Non-Life Safety Complying Kitchen Hood**

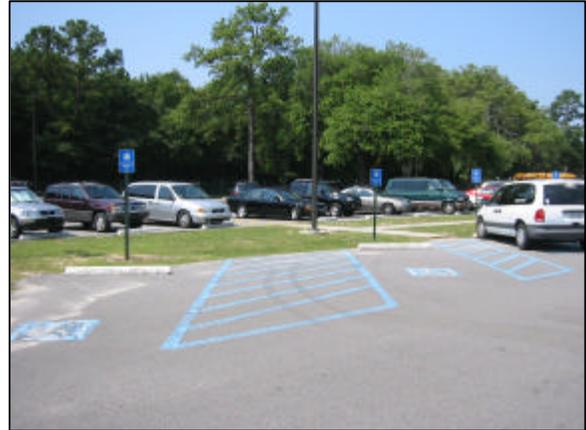
**Photo 2: Non-compliant Parking**

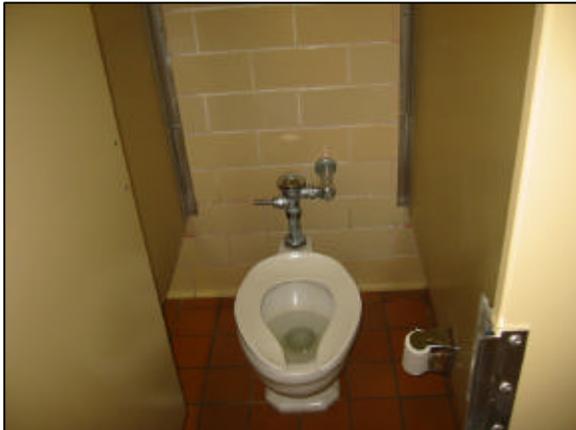
**Photo 3: Non-compliant Toilet**

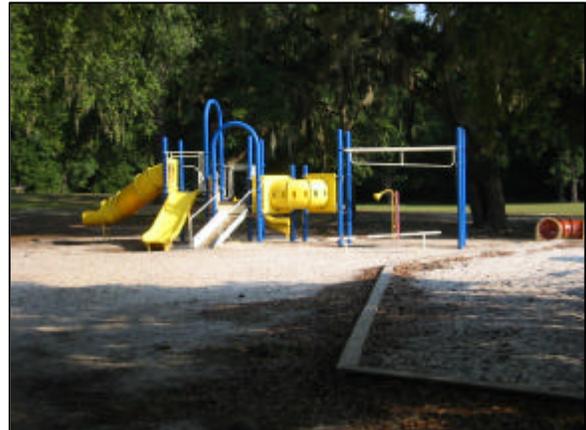
**Photo 4: Non-compliant Play Area**

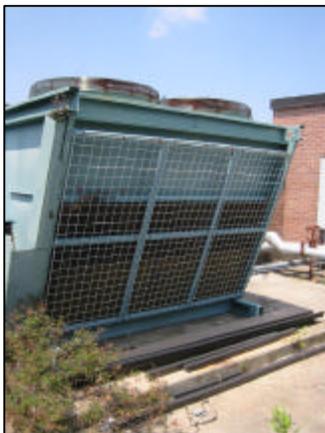
**Photo 5: Replace HVAC Unit**
