DDESS Facility Transfer Study Facility Condition Report (Final)

Dahlgren Naval Surface Warfare Center, Virginia

December 10, 2003

**DAHLGREN SCHOOL
DAHLGREN NAVAL SURFACE WARFARE CENTER, VIRGINIA
PROPERTY CONDITION REPORT**

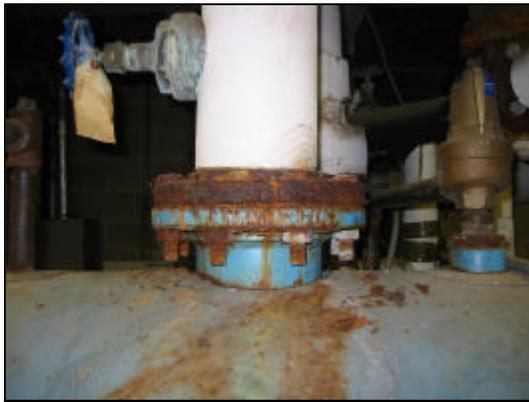
Photo 1 – Close-up of Rusted Boiler Flange

3.6.3 Mechanical System		
3.6.3.1 Heat Generating Equipment	X	
Heat is generated by a Kewanee 2040 MBH boiler fed by fuel oil located in the mechanical room. It supplies the hot water loop that feeds individual fan coil units. The boiler flanges and piping are rusted and corroded. The boiler casing is rusting at the seams. Boiler replacement and associated piping is required as a safety measure.

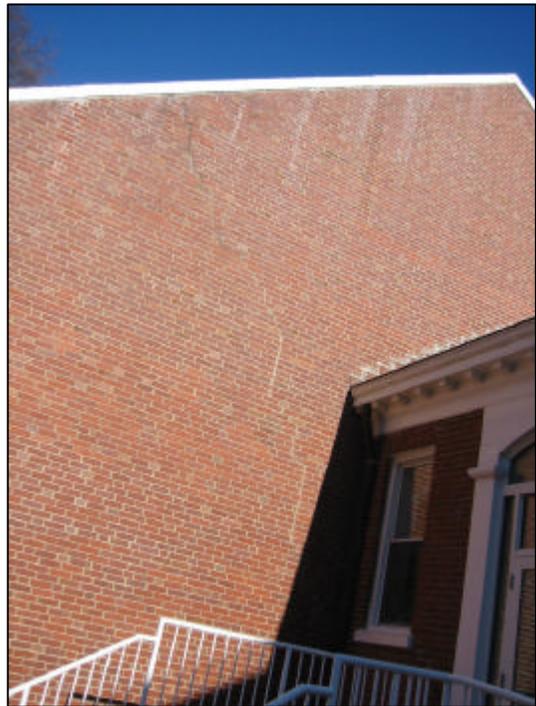
Photo 2 – Exterior Masonry Settlement Cracking. Original Building South Wall

Reference	Immediate	Long-term
compliance. No remediation recommended.		
3.3 Structural Frame and Building Envelope		
3.3.1 Foundation		
The foundation is assumed to be reinforced concrete grade beams, supported by spread and spot footings with concrete floor slab -on-grade in fair condition. Repair and stabilization of selected areas where masonry has cracked is required.	X

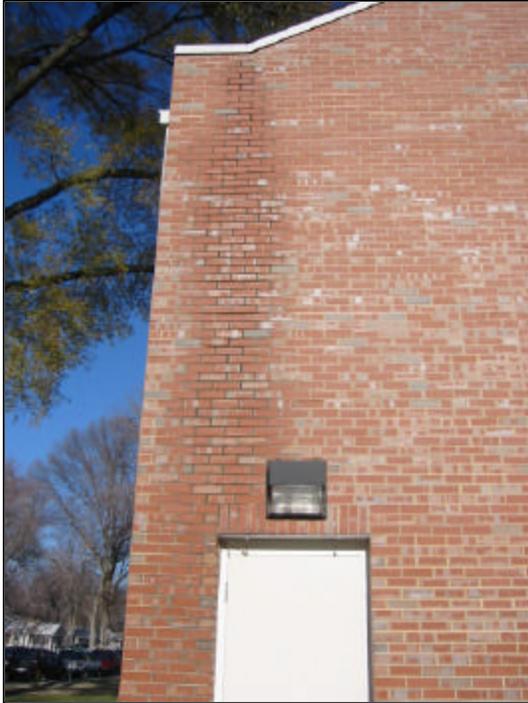
Photo 1 – Moisture Problem, Gymnasium

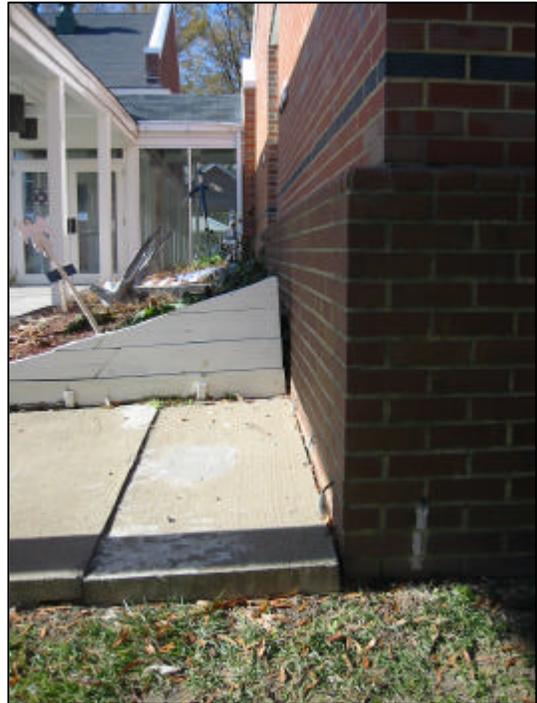
3.2.6 Landscaping and Appurtenances		
<p>Perimeter landscaping is highly developed. Some plantings around the 1994 addition are too close to the building and require rework to prevent moisture intrusion in the building.</p>	X

Photo 2 – Plantings Against Wall

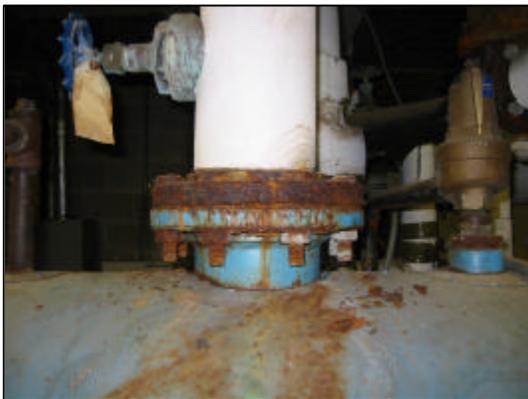
Photo 3 – Close-up of Rusted Boiler Flange

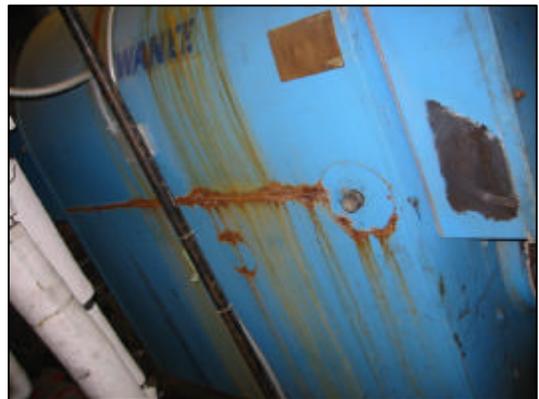
Photo 4 – Rusty and Deteriorating Boiler

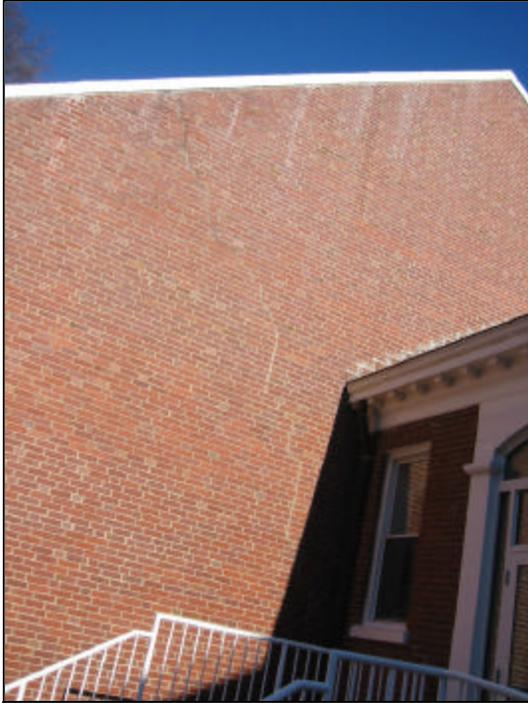
3.3.3 Facades or Curtainwall		
3.3.3.1 Sidewall System		
Building exterior is face brick masonry veneer in poor condition. Masonry exhibits surface deterioration, stress cracking, missing and damaged masonry units and grout, and efflorescence and algae growth in various locations. Repair and replacement of damaged masonry, grout and surface cleaning is recommended. See Section 3.3.2 for costs.	X	
Windowsills are face brick in fair condition. Repair and replacement of damaged areas and general cleaning is

**Photo 5 – Exterior Masonry Settlement Cracking.
Original Building South Wall**

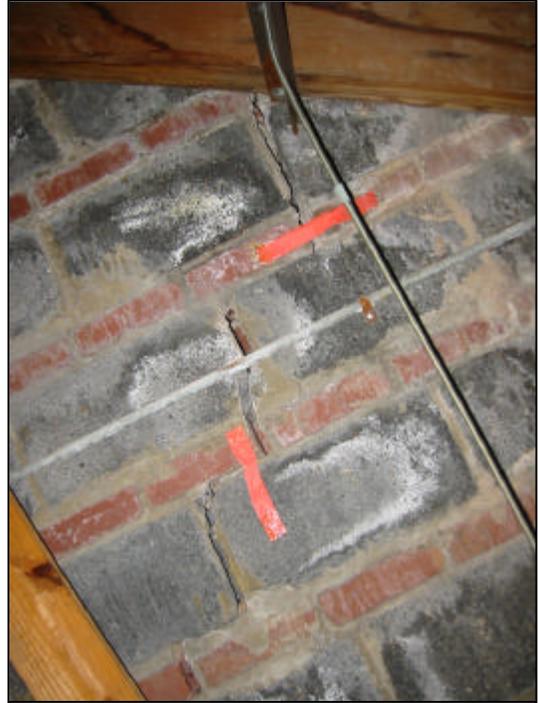
Photo 6 – Interior Cracking of South Exterior Wall. Original Building.
