DDESS Facility Transfer Study Facility Condition Report (Final)

Fort Campbell, Kentucky

December 10, 2003

FORT CAMPBELL SCHOOLS
FORT CAMPBELL, KENTUCKY
PROPERTY CONDITION REPORT

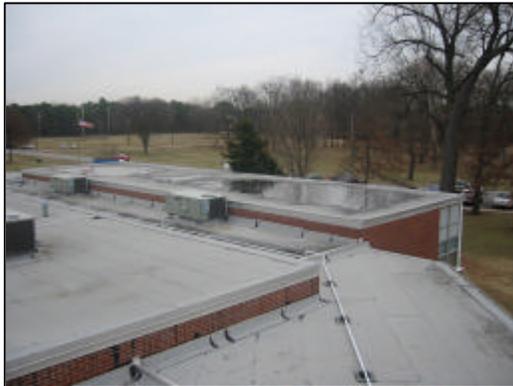
Roof Ponding

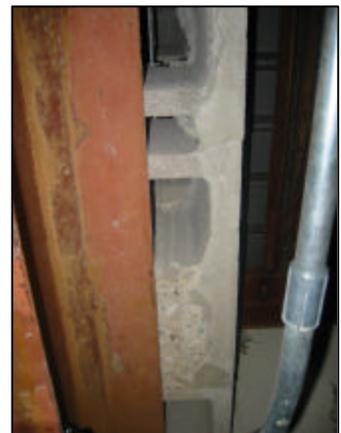
Photo 6: Structural Support Needed

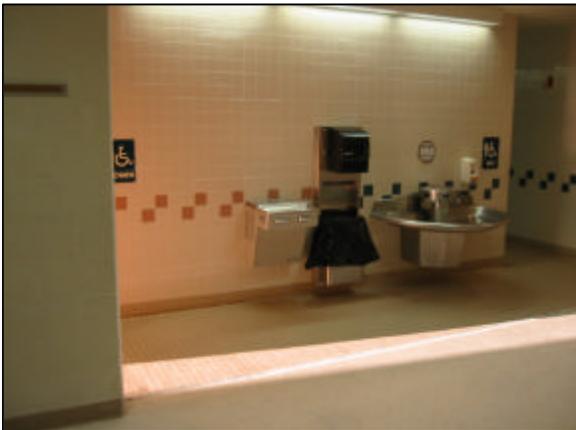
Photo 3: Compliant Fixtures
